**Due Diligence Building Condition
Review**

The West Side Collection Portfolio, Vancouver, BC

Report No. 2100880.00

January 21, 2021

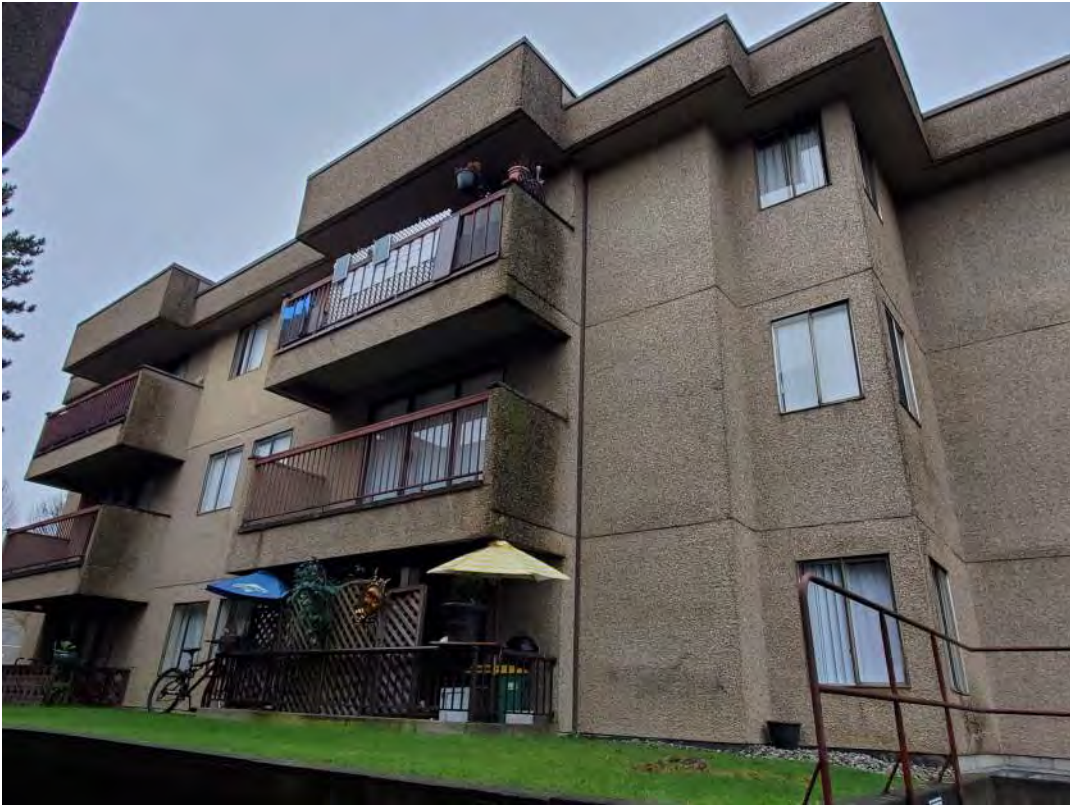
AC01

The parkade roof is a reinforced concrete suspended slab supported on reinforced columns and the foundation walls. There is no membrane on the slab where it extends beyond the footprint of the building (photo AC01). Numerous active leaks were noted (photo AC03) as well as some light spalling.

The walls are heavily stained, particularly along the east elevation, guardwalls and upper floors (photos AC01, 02). The balance of the walls benefit from a significant roof overhang and staining is limited. Some localized crack repair is evident (photo AC05), but no significant cracking of the stucco was noted.

Repairs to seal active leakage are recommended. If leakage is no longer manageable by a maintenance program or significant spalling occurs, consideration could be given to protecting the slab with a membrane.

The building should be cleaned, any cracking addressed. Exploratory openings should be undertaken to confirm the condition of the underlying wood components. A re-clad should be considered at some point beyond the 10-year horizon of this report.

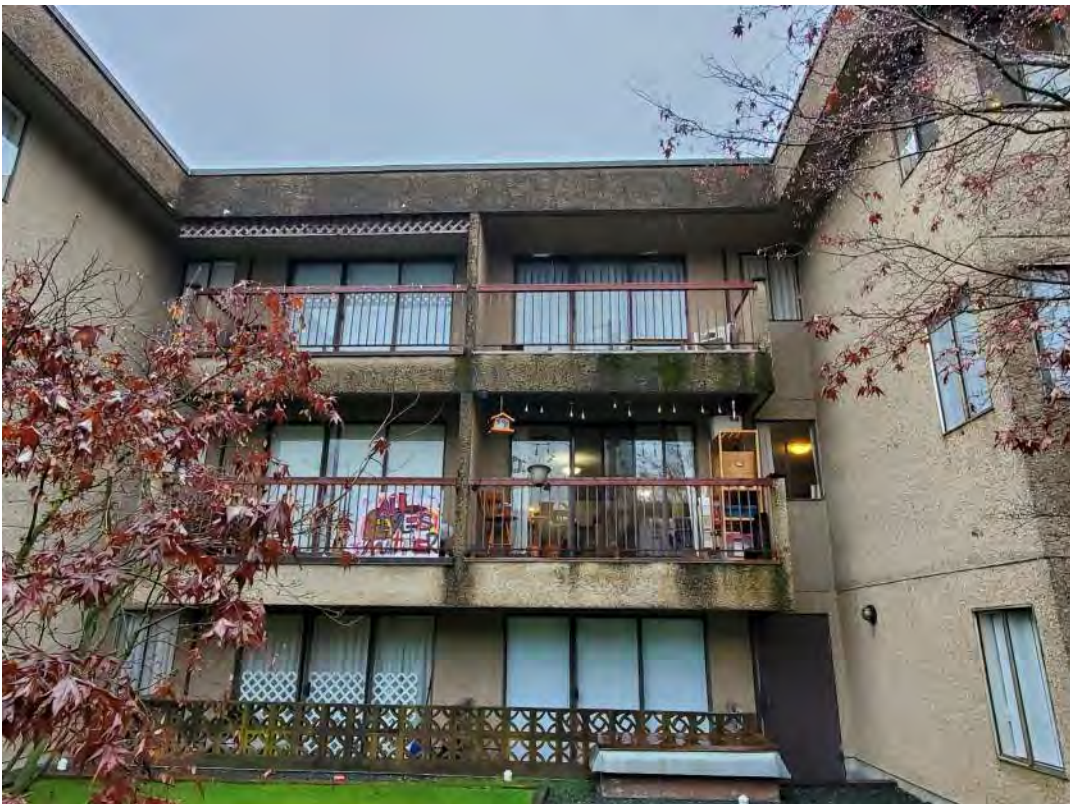
AC02

The heavy staining and corrosion suggest that the stucco wall is experiencing repeated wetting cycles. While no evidence of leakage was noted or reported, damage to the underlying wall assembly is possible if the walls aren't drying out between wetting cycles. In older buildings, there is typically a significant amount of air leakage from the interior which helps dry the wall assembly from the interior.

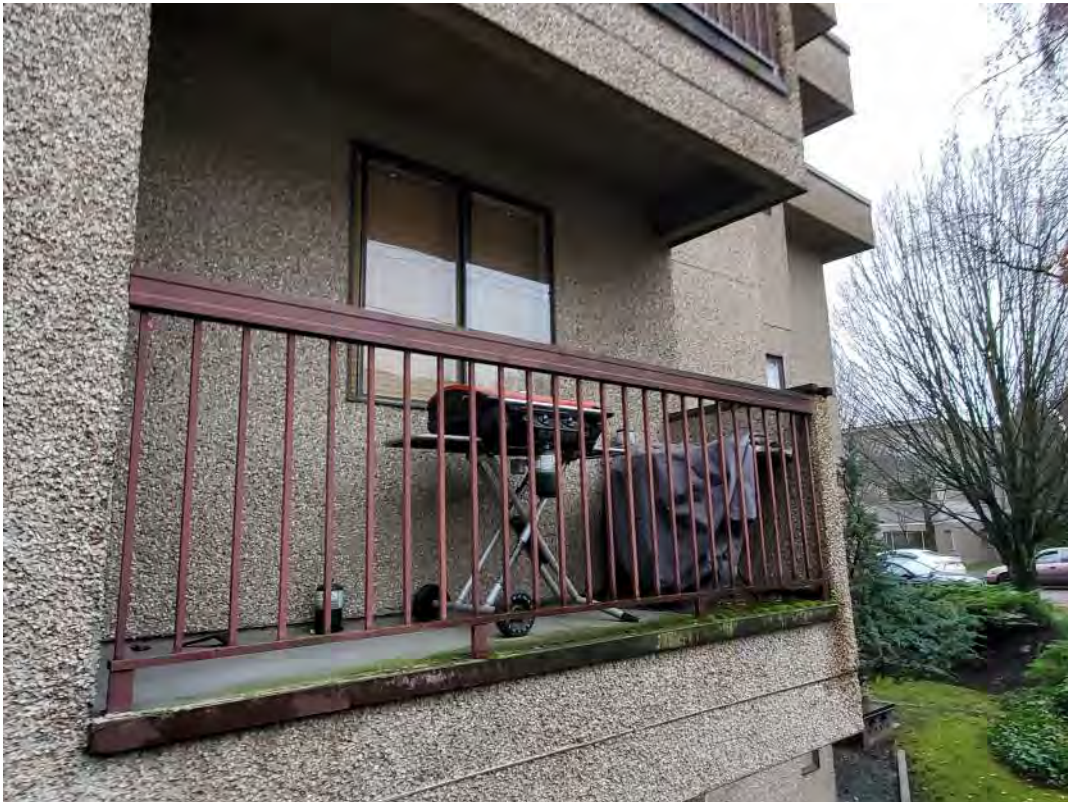
AC04

Units are provided with framed balconies, cantilevered (photo AC04). The balcony floors are coated with a liquid membrane, ages vary as work is done as suites are updated. The soffits are stucco. No signs of distress were noted at balconies. Targeted deck restoration was undertaken in 2016/2017.

Balcony membranes appear to be renewed with suite upgrades. It was reported that any repairs to the structure are undertaken at that time. A budget for continued renewal including replacing any soft plywood decking and review of the structural system is recommended.

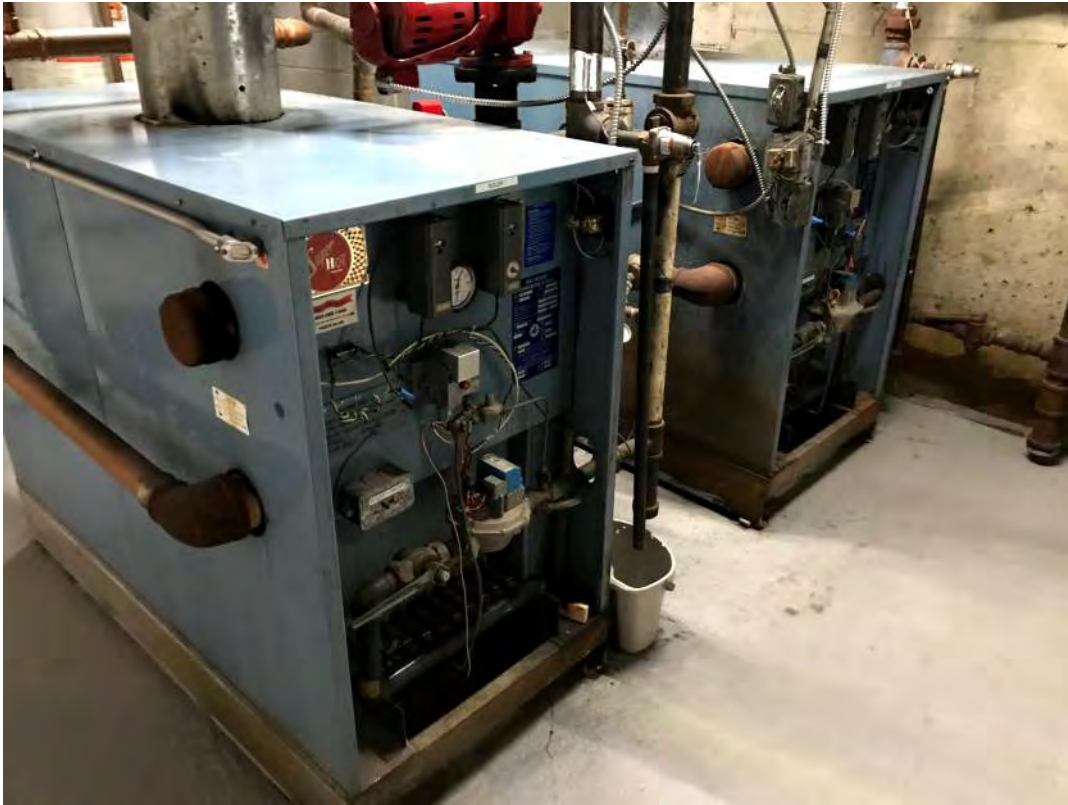
AC09

The building is heated by hydronic baseboard heaters. Heating hot water is generated by two Super Hot 600 MBH input boilers (photo AC09) inside the basement boiler room. Heating hot water is distributed to the building via a circulator pump. The boiler system was installed in 1986 and is due to be replaced in the next 5 years.
