Arbutus Court

Condition Assessment Report

8740 Cartier Street
Vancouver, BC

October 02, 2020
RJC No. VAN.040210.0020

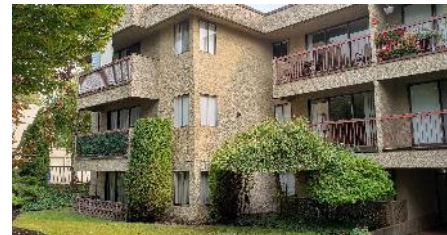
Figure 1 - Overview of building

- .1 Overall, the building is in reasonable condition for its age and is generally maintained.
