Client:	CAPREIT GP Inc.	Report Date:	23-Mar-2021
Attention:	John Fitzgerald Anuradha Bandara Maria Trotea	Email:	JohnF@CCMSProjects.com A.Bandara@capreit.net m.trotea@capreit.net
Contractor:	The Restorers Group Inc.	Email:	pat@restorersgroup.ca
Project:	12184,12186,12188 & 12190 224 Street Maple Ridge, BC- Balcony Repairs.	Site Visit:	23-Mar-2021
		Weather:	11°C

OBSERVATIONS AND COMMENTS:

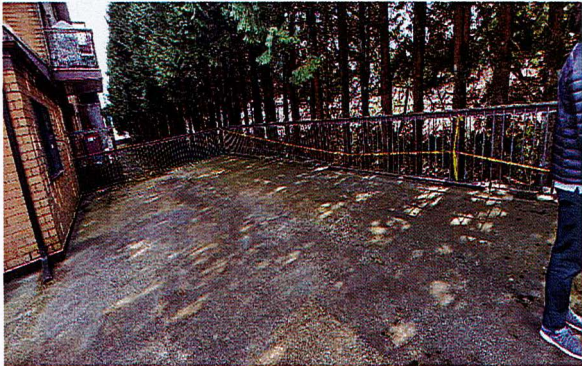
No.	Description	Photo
1.1	Railings on the concrete slab between building B and C (beside Rental Office) were observed unsafe. New aluminium guardrails are recommended. MPL recommends installation of temporary barricade to prevent any accidents.

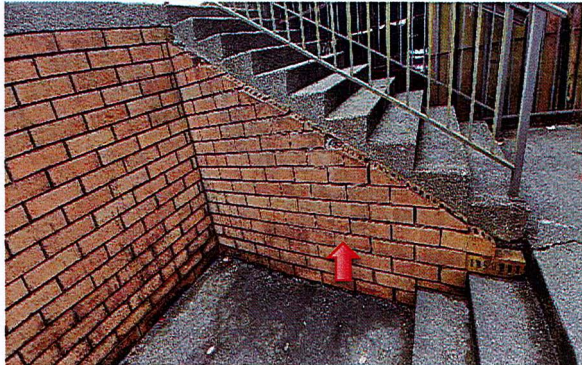
1.2	Brick veneer grouted joints on stair at north elevation of building D were observed typically damaged. MPL recommends local brick veneer repairs and repointing. Repointing of joints is recommended if damaged joint is encountered anywhere else.

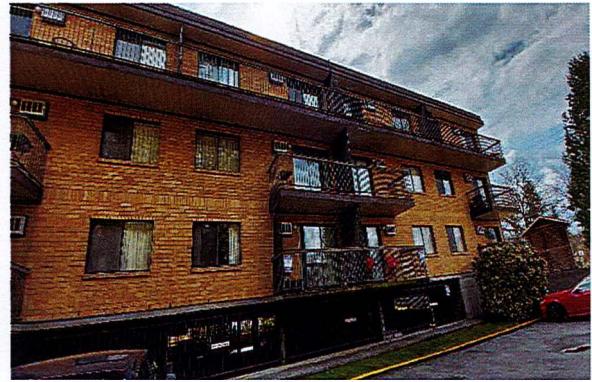
1.3 As per the site meeting, commencement of balcony repair work will begin on south elevation of building 12184 (Building D).

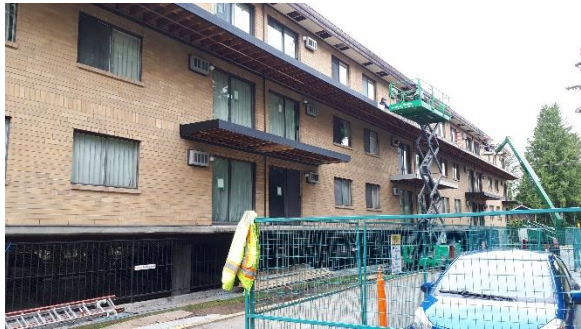
No.	Description	Photo
2.1	The demolition of the existing guardrails and removal of the existing membrane is completed on the North elevation of building B. The Contractor was observed working on the structural repairs and plywood replacement.

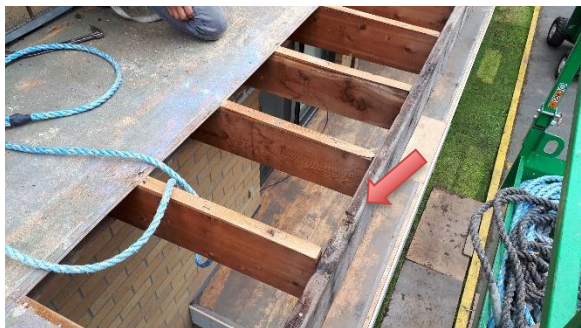
2.2	The existing balcony cantilevered joists were observed in general in fair condition at all locations reviewed. The existing rim joists was observed locally rotted (minor damages at the locations reviewed) the rot shall be removed and the stained areas treated with Boracol.

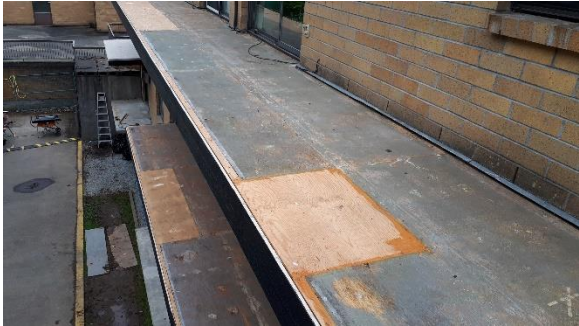
<p>2.3</p>	<p>Plywood replacement was observed in progress.</p>

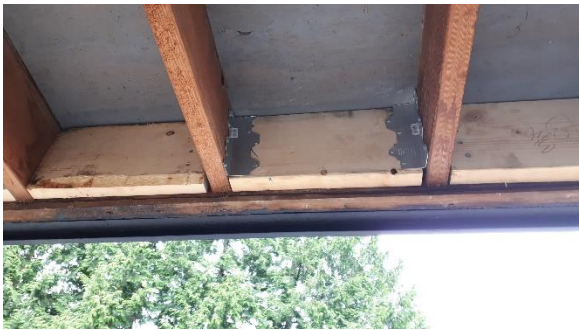
<p>2.4</p>	<p>Installation of a second ply of continuous rim joist and comb face fascia was observed in progress. At the future locations of the guardrails post (4'o.c.) A blocking was observed installed with Simpson Strong tie angles.</p>

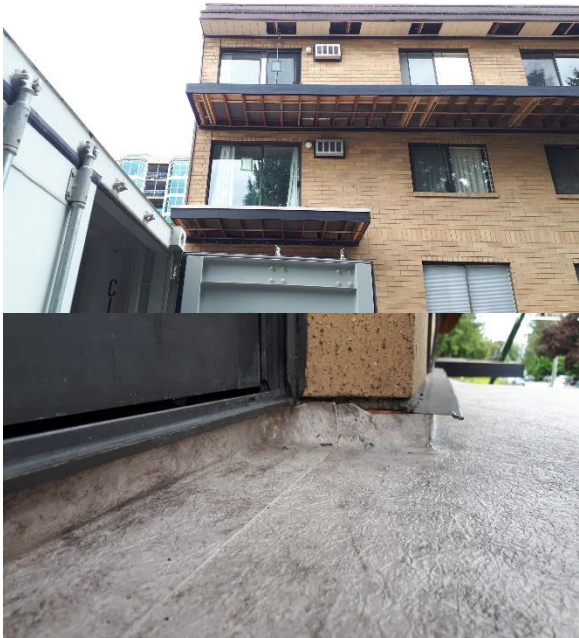
<p>2.5</p>	<p>A mock-up presenting the vinyl membrane installation was put together on a second-floor balcony.</p> <p>The vinyl membrane was observed upturned at the wall base and sealed under the brick veneer base flashing and onto the balcony sliding door flange.</p> <p>A water diverter was observed installed at the balcony saddle.</p>

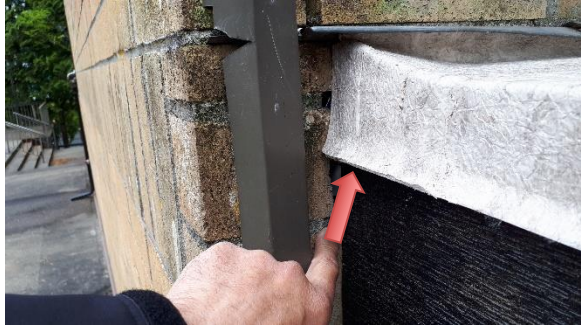
2.6	<p>Backer rod & caulking are recommended to be installed at the interface between the brick veneer and the vinyl membrane/ comb face fascia.</p> <p>The balcony drip flashing is recommended to be secured (i.e. wood blocking installed under the flashing to restrain movement) before the caulking installation.</p> <p>The Contractor to clarify the sealant for vinyl/ brick interface – adhesion test is recommended.</p>

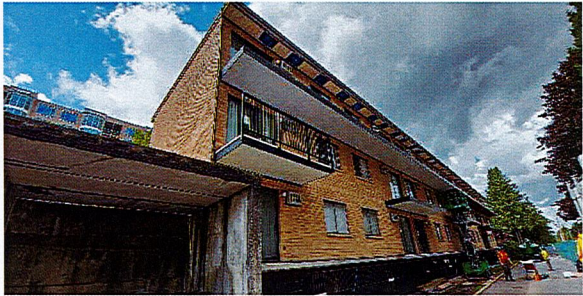
No.	Description	Photo
3.1	During the site visit installation of new aluminium soffit was observed in progress.

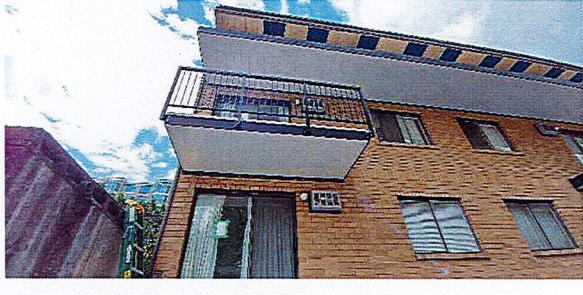
3.2	Preparation of railing mock-up was observed in progress at Unit 208 balcony.

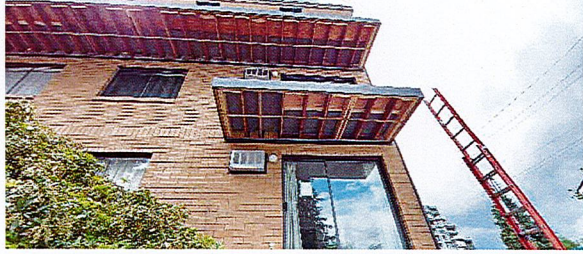
3.3	Structural repairs at balcony were completed, 2-2x8 rim joist and 1-2x8 blocking at guardrail post location were installed. Locally damaged balcony joist was sistered with new 2x8 member on both sides. Work appears satisfactory.

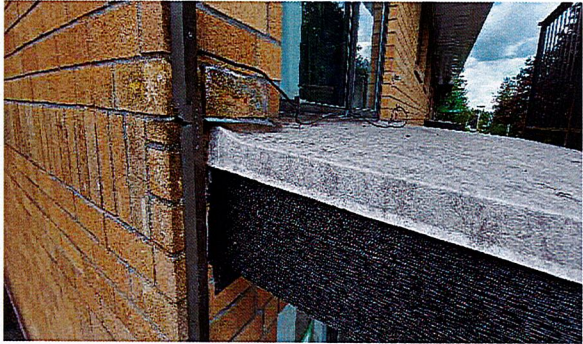
3.4	As per previous recommendation, backer rod & caulking to be installed at the interface between the brick veneer and the vinyl membrane/ comb face fascia. The Contractor to clarify the sealant for vinyl/ brick interface – adhesion test is recommended.

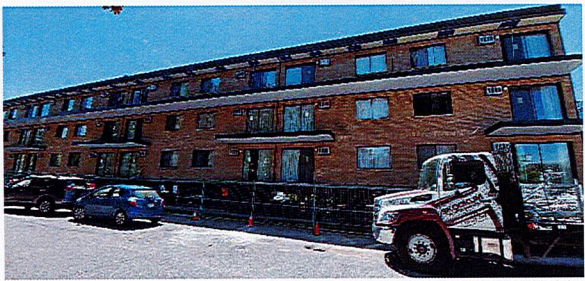
No.	Description	Photo
4.1	During the site visit new aluminium soffit was installed at all balconies.

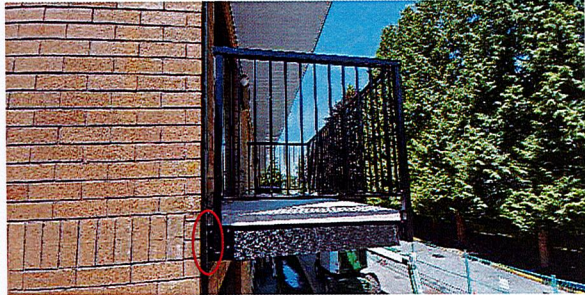
4.2	Balcony guardrail mock-up at Unit 208 was reviewed and found as per recommendations. Installation of similar guardrail on all other balconies can be proceeded. The contractor was observed using "TREMCO-Dymonic 100 sealant" at vinyl membrane and brick veneer interface.

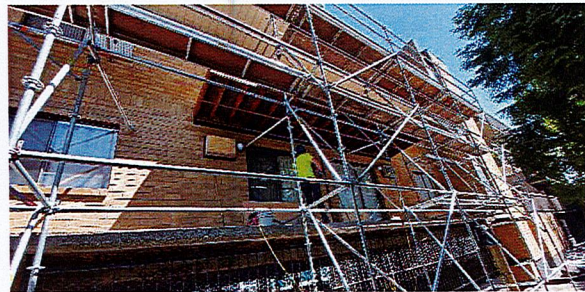
4.3	Installation of scaffolding on south elevation of Building B was observed in progress. Demolition of existing guardrails and removal of existing membrane was initiated. If any rot found in balcony joist or rim joist, similar repair to be followed as performed on north elevation.

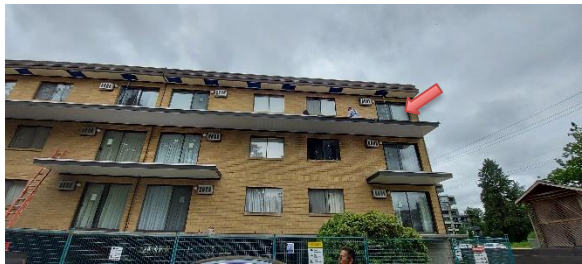
No.	Description	Photo
5.1	During the site visit installation of vinyl membrane on 3 rd floor balcony was observed in progress at north elevation of building D. Once the membrane installation is completed, installation of guardrail and privacy screen can be started.

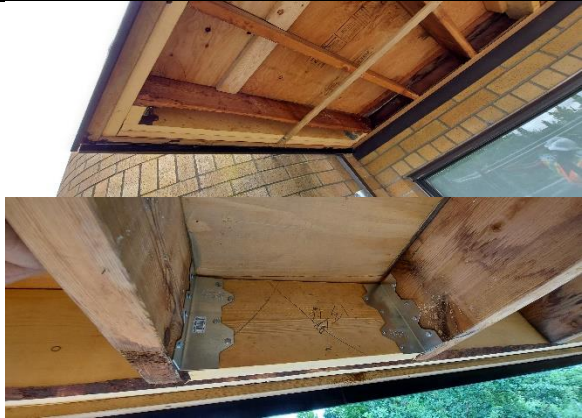
5.2	On South-West elevation of Building D, balcony structural repairs was observed in progress. Structural repairs performed were: - 3 Ply (2"x8") balcony end joist, - 2 Ply (2"x8") rim joist, - addition of 2"x8" blocking (total 3 Ply) at every railing post connection. Simpson strong Ties L70 were used to connect blocking (2"x9") to balcony joist.

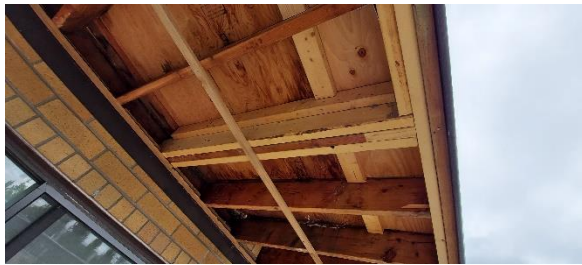
5.3	Existing balcony joist were sistered with new 2"x8" member, on both sides if section lost due to rot is more than 20% and on one side if section lost due to rot is less than 20%.

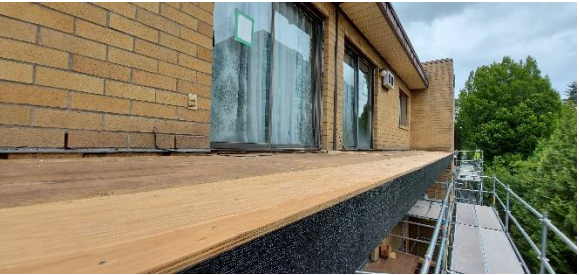
5.3	New 3/4" plywood sheathing was installed at rot locations. New fascia board (1/2" x9") was installed.

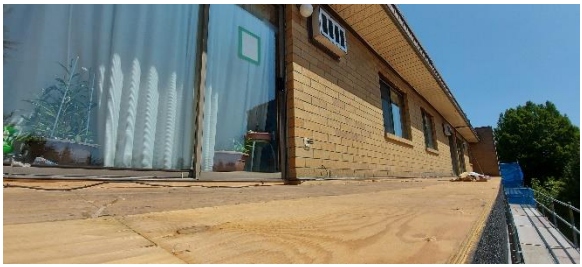
6.4	<p>On south elevation, 3rd floor balcony was ready for installation of new vinyl membrane.</p> <p>Wooden cricket to be installed at balcony corners as instructed on site.</p>

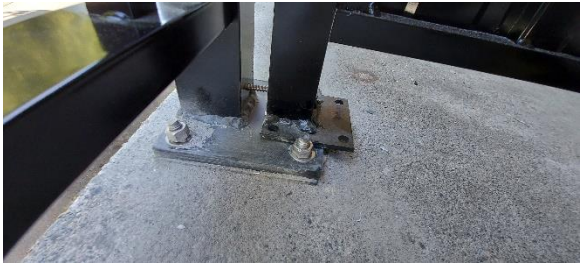
6.5	<p>MPL recommends privacy screen post base plate to rest on slab and not on the guardrail post base plate.</p> <p>Use neoprene gasket under the privacy screen post base plate.</p> <p>If required a spacer is recommended between the guardrail/privacy post.</p> <p>Avoid such sharp edge projections to prevent any hazard.</p>

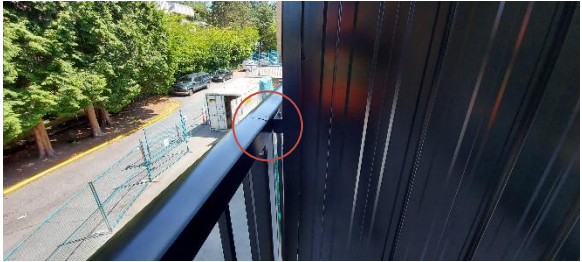
6.6	<p>At connection of privacy screen post to guardrail top rail, MPL recommends contractor to install similar angle connection on other side (both sides) of post.</p>

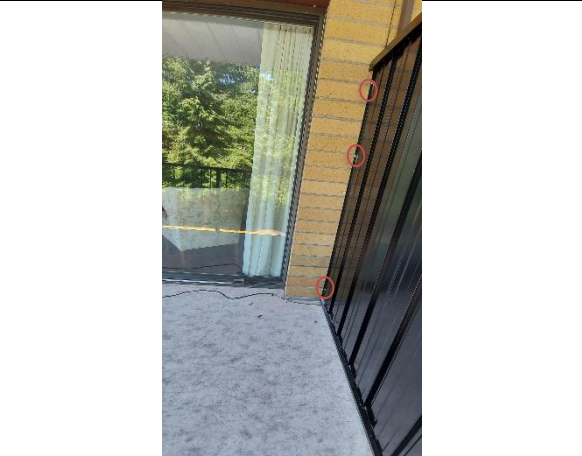
6.7	<p>3-#12 stainless steel screws 2" long was used to connect privacy screen to masonry wall cladding.</p> <p>Contractor to make sure the screws are well secured in the masonry joint.</p>

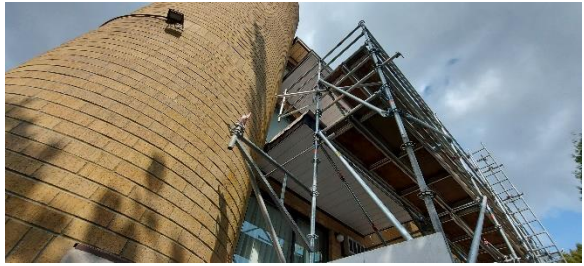
No.	Description	Photo
7.1	On south elevation of building D, all balcony structural repairs were completed, new vinyl soffits were installed; installation of new vinyl membrane was in progress.

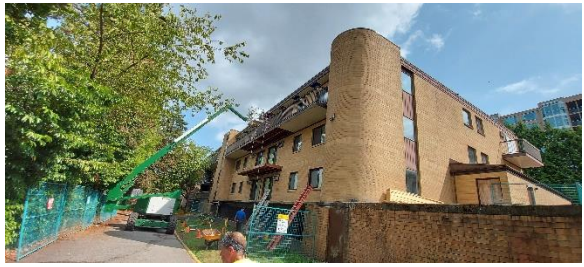
7.2	During the site visit, contractor was observed working on Building C south elevation. Repairs were performed with the help of boom lift.

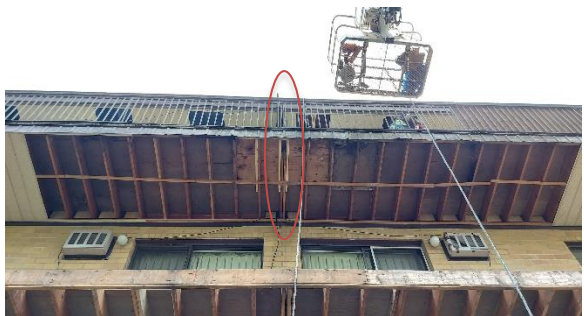
7.3	One balcony joist at 3 rd floor was observed rotted which was repaired in past. Previously repaired joist was inappropriately done by simply sistering 2 small pieces of 2x8 on rot joist; with rot left behind. MPL recommends contractor to cut the rot portion of joist and sister 2 full length 2x8 joist to existing joist; the rot portion of joist to be filled with 2x8 piece or plywood. Rotted/damaged plywood sheathing to be replaced with new 5/8" plywood T &G.

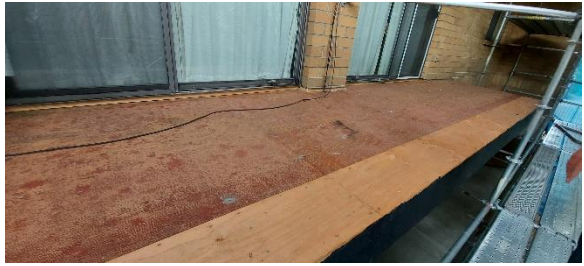
No.	Description	Photo
8.1	Repair work at south elevation of building D were reviewed and found satisfactory. Contractor was advised to use screws instead of nails for deck sheathing attachment.

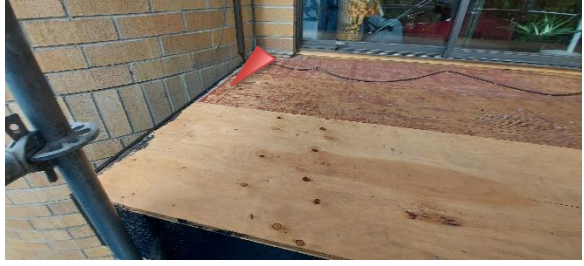
8.2	Wooden crickets to be installed at balcony corner similar to south-west corner balcony.

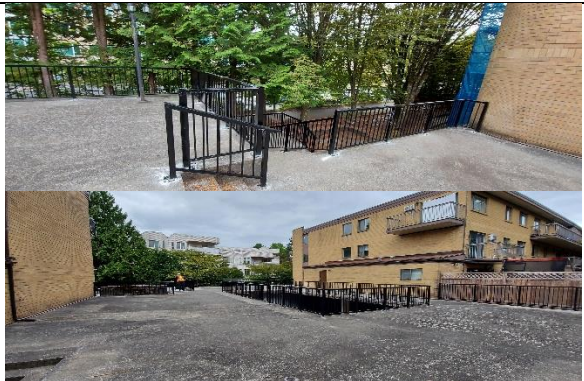
8.3	New aluminium railings at stair and common area between building D & C were installed. Installation of railings were found satisfactory.

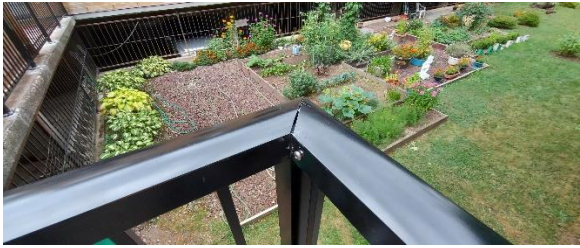
<p>8.4</p>	<p>At common area between building B & C, corner sleeve to be installed because of poor finish corner and safety reason.</p>

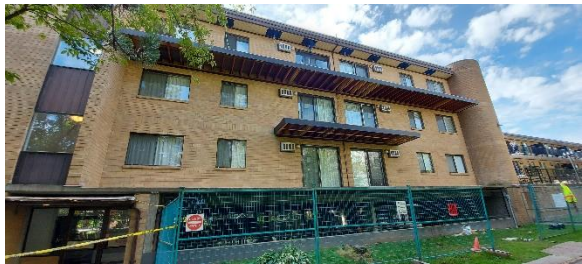
No.	Description	Photo
9.1	During the site visit balcony structural repairs were completed on Building C south elevation units #201, #202, #301, & #302.

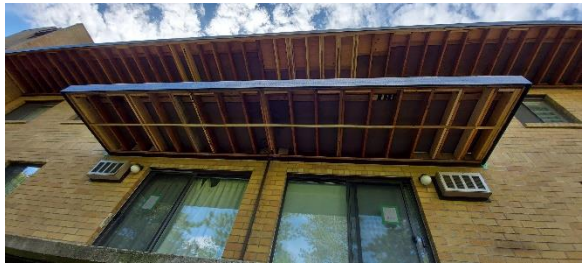
9.2	Damaged balcony joist were sistered with new 2x8 member, new blockings were installed at guardrail post locations, damaged plywood sheathing were replaced with 5/8" plywood sheathing & end joist were made 3 ply 2x8. Work appears satisfactory.

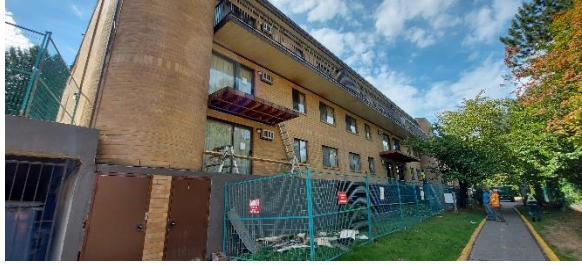
9.3	Removal of existing guardrails, soffit, vinyl membrane was in progress at units #203, #204, #205, #303, #304 & #305

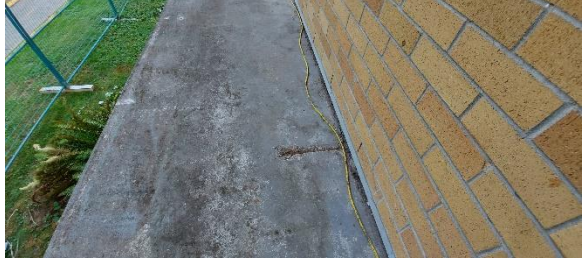
9.4	Localized balcony slab reinforcement was observed exposed and corroded at units #104, & #105. MPL recommends cut-remove concrete around the exposed rebar, coat it with corrosion resistance paint and then fill the repair area with new cement mortar.

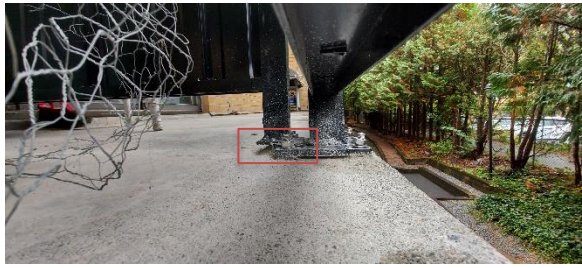
10.2	<u>Building D - south elevation:</u> As recommended neoprene gasket were installed under the post base plate. Connections were reviewed and found satisfactory. Privacy screen base plate to rest on slab and not on the guardrail post base plate. Contractor to avoid any sharp edge projections (privacy screen base plate) to prevent any hazard.

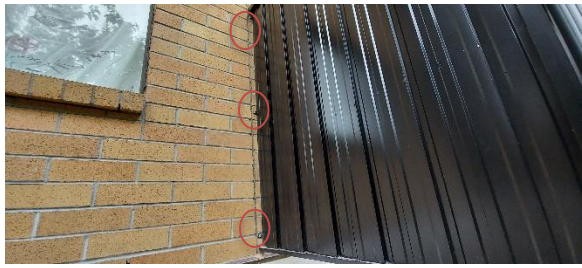
10.3	<u>Building D - south elevation:</u> Privacy screen were connected to wall with 3-#12 stainless steel screws 2" long.

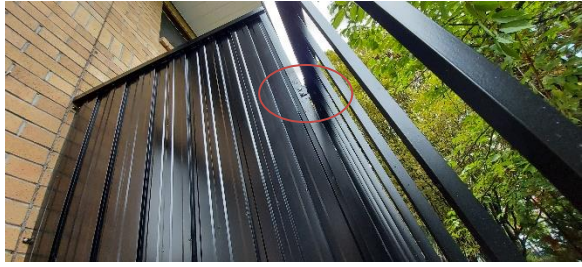
10.4	<u>Building D - south elevation:</u> As recommended privacy screen post were connected to guardrail top rail with angle connections on both sides.

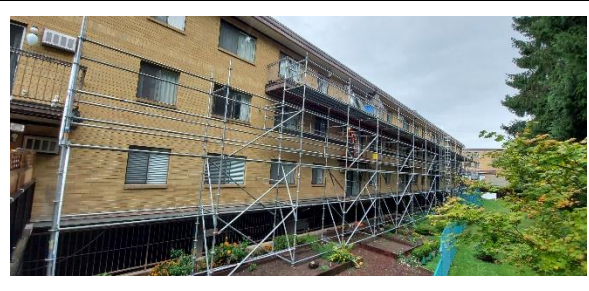
10.5	<p>Installation of scaffolding on south elevation of building C was completed.</p> <p>Removal of existing guardrails, vinyl membrane & vinyl soffit was in progress.</p>

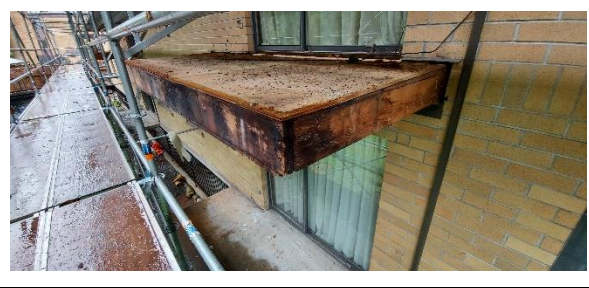
10.6	<p><u>Building C - south elevation</u>: Unit 208, localized damage was observed on rim joist and end joist, repairs to be performed as per the detail drawings provided.</p>

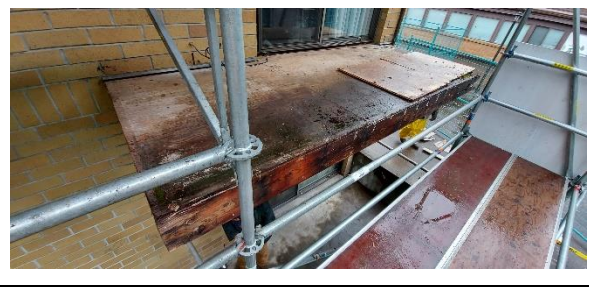
10.7	<p><u>Building C - south elevation</u>: Unit 211, deck plywood sheathing, rim joist and balcony end joist were observed damaged.</p>

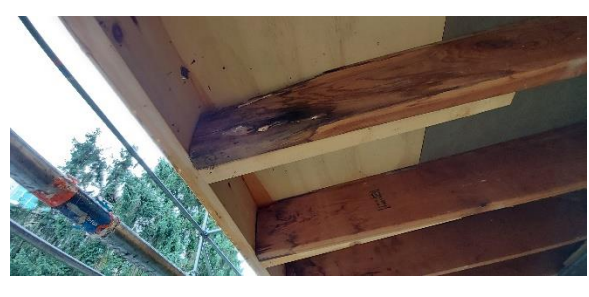
10.8	<p><u>Building C - south elevation</u>: Unit 210, localized portion of the balcony was inappropriately repaired in past, the rot joist was sistered with 2x8 piece, but the rot portion of the joist was not removed.</p> <p>MPL recommends contractor to cut/remove the rotten portion of joist and sister new 2x8 piece full length as per detail drawings.</p>

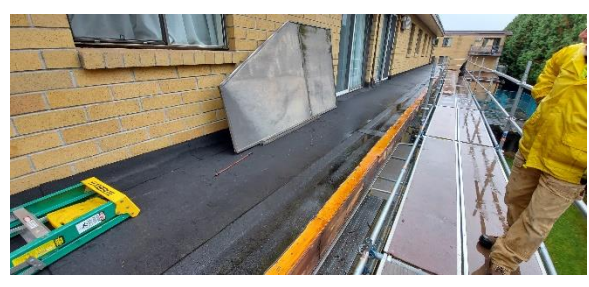
10.9	<p><u>Building C - south elevation</u>: 3rd floor balconies, the existing membrane observed was torch on membrane, peeling SBS membrane without damaging the plywood sheathing is impossible so MPL recommends new 5/8" plywood sheathing to be installed on 3rd floor balconies.</p>

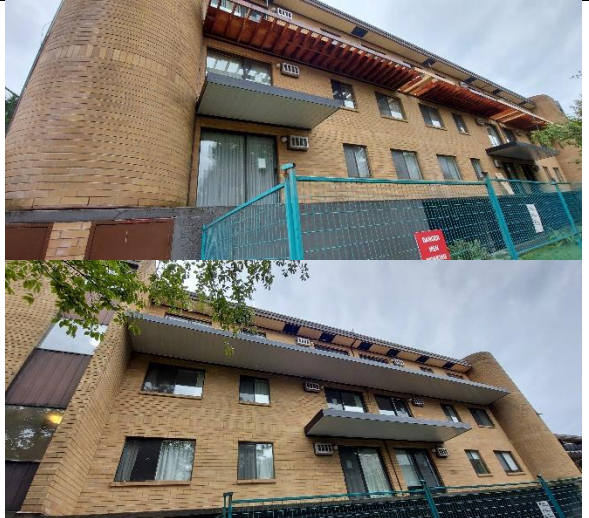
10.10	<p><u>Building C - North elevation</u>: structural repair at unit 201, 202, 203, 204, 205, 301, 302, 303, 304, & 305 balconies were completed.</p> <p>Structural repair at balcony 303, 304, & 305 were reviewed and found satisfactory.</p>

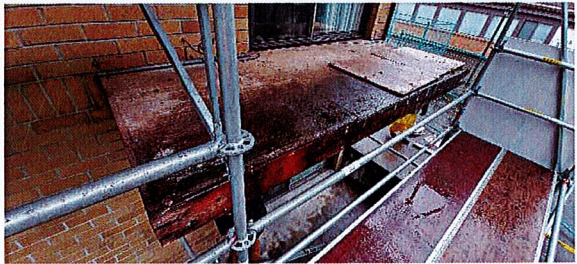
11.2	<u>Building C - south elevation:</u> Unit 211, deck plywood sheathing, rim joist and balcony end joist were observed damaged. Repair to be done as per MPL drawings.

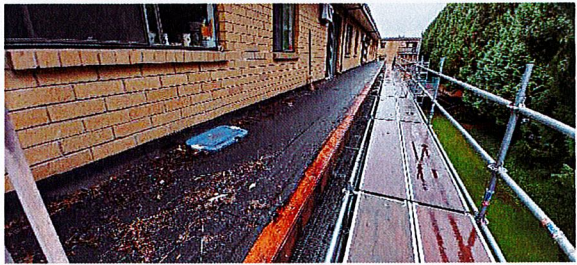
11.3	<u>Building C - south elevation:</u> 3 rd floor balconies, the existing membrane observed was torch on membrane, peeling SBS membrane without damaging the plywood sheathing is impossible so MPL recommends new 5/8" plywood sheathing to be installed on 3 rd floor balconies.

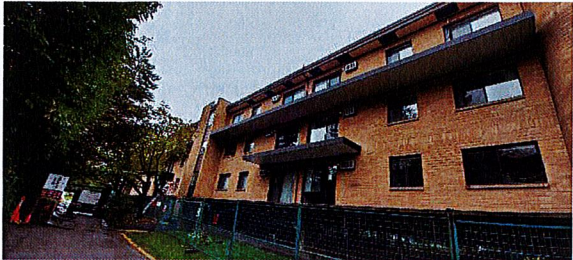
11.4	<p><u>Building C - North elevation:</u> structural repair at unit 201, 202, 203, 204, 205, 301, 302, 303, 304, & 305 balconies were completed. Structural repair at balcony 303, 304, & 305 were reviewed and found satisfactory.</p>

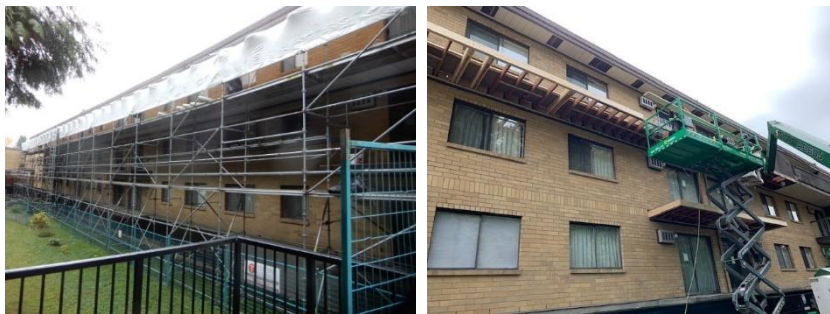
No.	Description
12.1	Repairs were in progress at Buildings C and B. Repairs were completed at Building D. No work commenced at Building A

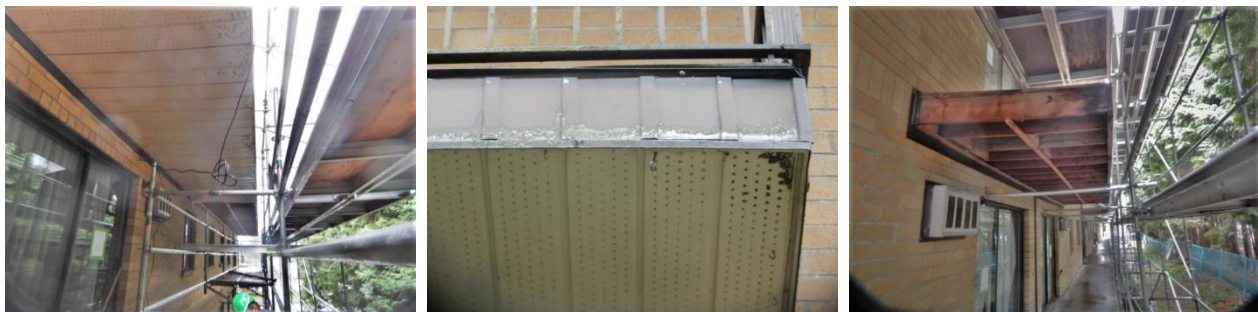
12.2	Balcony soffits were observed to be excessively fastened, leading to irreversible damages at the removal. All soffits were to be replaced with new. Approximately 455 sqm was confirmed.
------	------------------------------------------------------------------------------------------------------------------------------------------------------------------------------------------

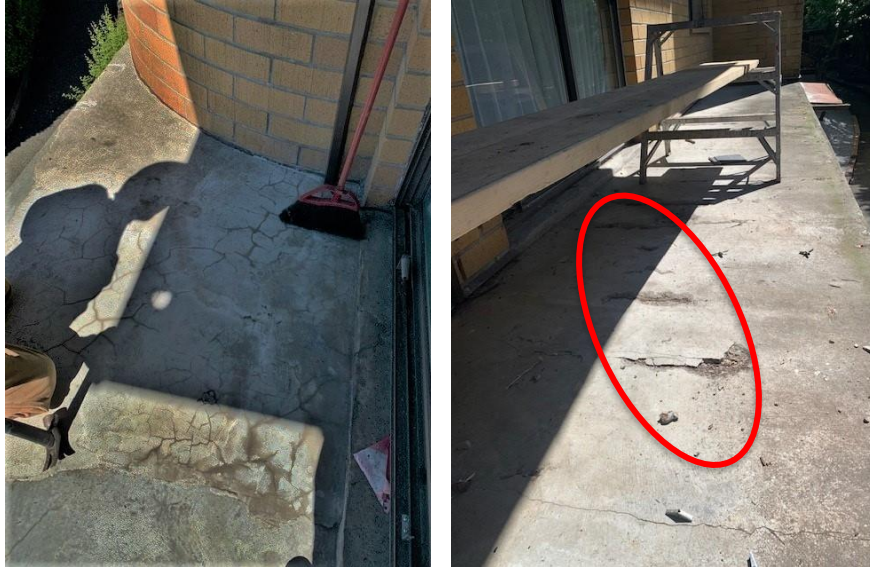
- 12.3 Concrete delamination was found in various areas on the second floor decks. Approximately 29 sqm more was confirmed that is needed to be repaired to complete the work.

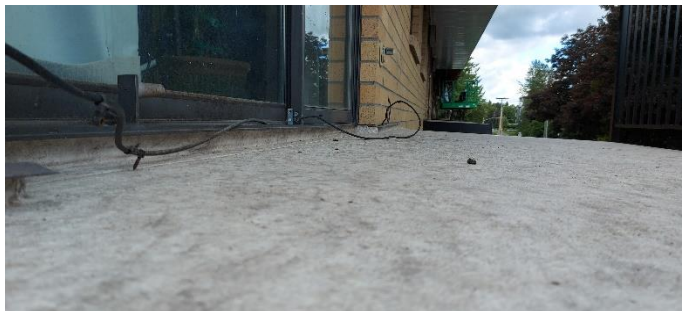
- 12.4 It is confirmed that new waterproofing membrane should be installed on approximately 99 sqm more than initially estimated.

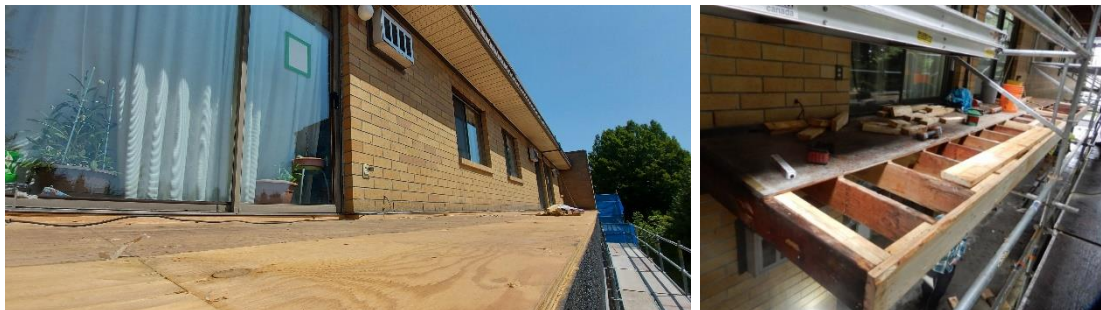
- 12.5 Removal of damaged sheathing (including areas that couldn't be salvaged at the removal of the SBS membrane applied on top), is approximately with 150 more than initially estimated.

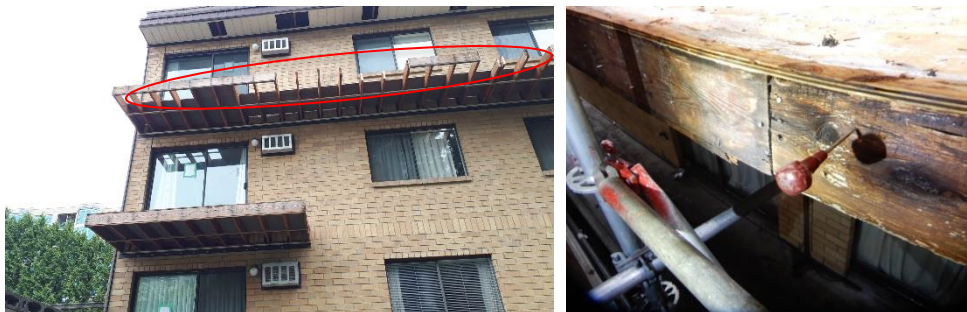
- 12.6 It is confirmed that 135 lm more of front headers needs to be replaced.

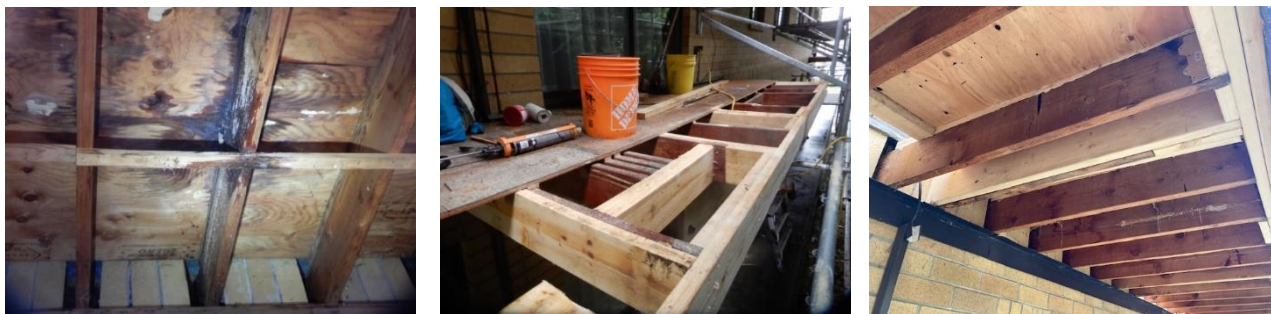
- 12.7 It is confirmed that rot repairs is needed on 474 lm more of wood joists than initially estimated.

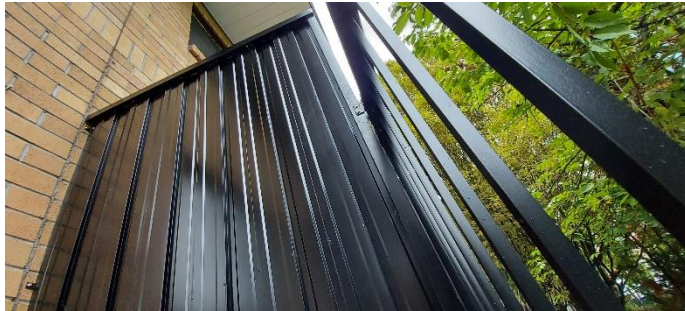
12.8 Thirty-two (32) more dividers need to be replaced.

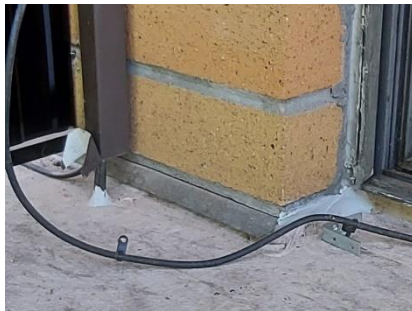
12.9 The furring at the upturns for the extra waterproofing membrane was estimated at 270lm.

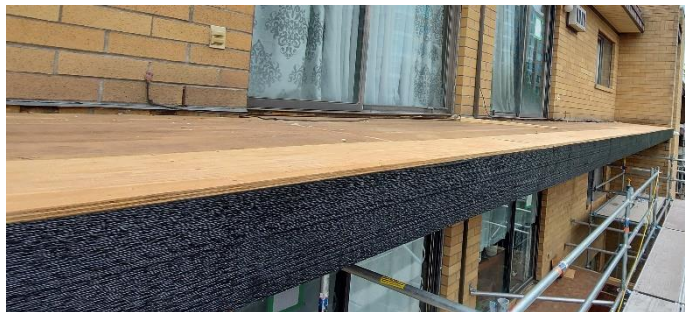
12.10 Extra new wood fascia was confirmed to be approximately 393 lm.

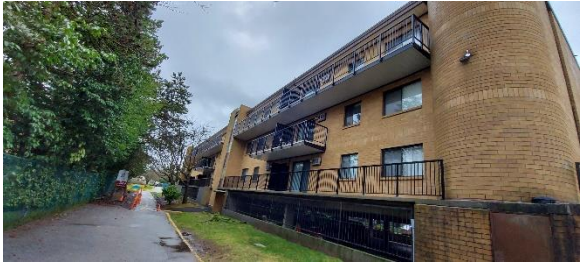
No.	Description	Photo
13.1	<u>Building C - North Elevation:</u> Balcony repairs were completed along with new balcony railings installation. Work appears satisfactory.

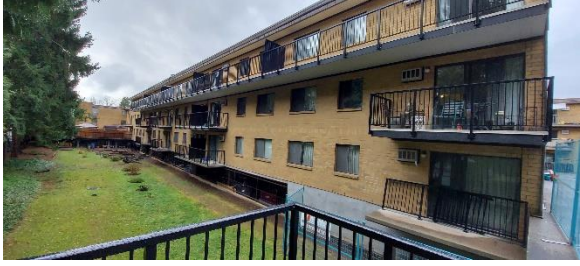
13.2	<u>Building C - South Elevation:</u> Installation of new railings 95% completed.

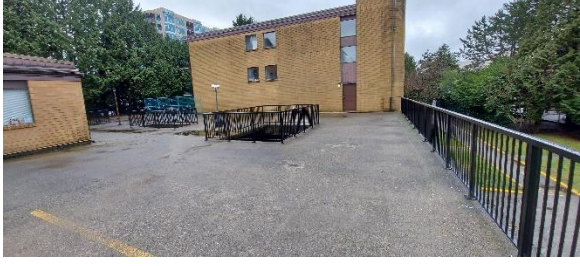
13.3	<u>Common area between building C-B:</u> New railings installation were reviewed and found satisfactory.

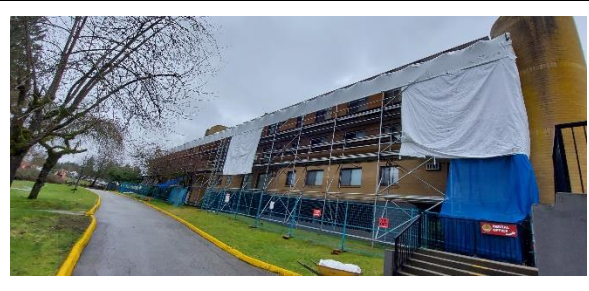
<p>13.4</p>	<p><u>Building B – North Elevation:</u> Balcony structural repairs were completed. Installation of new vinyl membrane awaiting.</p>

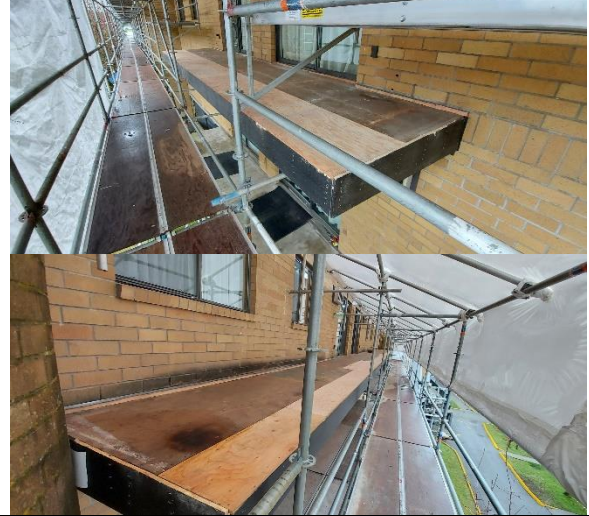
<p>13.5</p>	<p><u>Building B – North Elevation:</u> 2nd & 3rd floor structural repairs were completed; damaged plywood sheathing were replaced with new 5/8" plywood sheathing.</p>

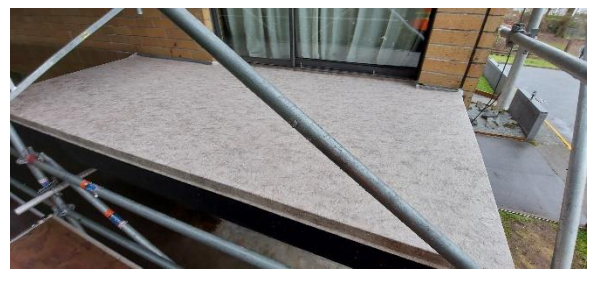
<p>13.6</p>	<p><u>Building B – South Elevation:</u> Installation of new vinyl membrane on all balconies completed. Cricket detail at balcony corners were reviewed and found satisfactory, installation new guardrails can be proceeded.</p>

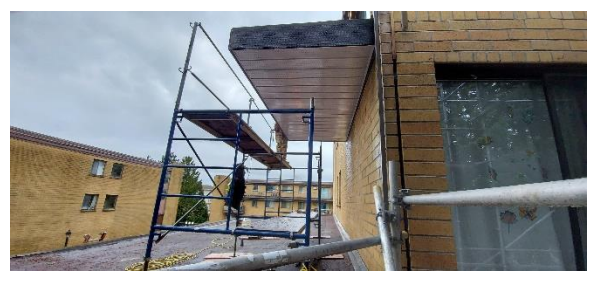
<p>13.7</p>	<p><u>Building B – West Elevation:</u> Installation of new vinyl soffit was observed in progress.</p>

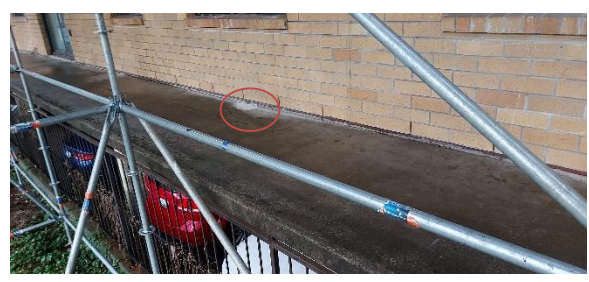
<p>13.8</p>	<p><u>Building B – South Elevation:</u> 1st floor balconies, localized concrete repairs were completed.</p>

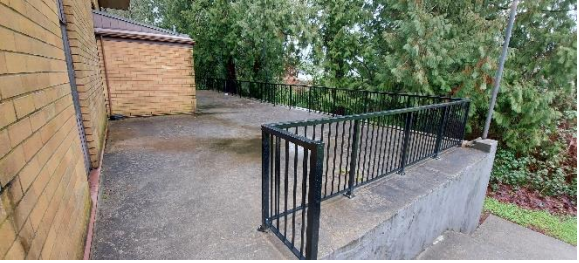
13.9	<p><u>Building A – East Elevation:</u> New railings were installed on parkade slab (common area). Railing connects were reviewed and found satisfactory.</p>
