# FINAL Baseline Property Condition Assessment

2244 West 6th Avenue,  
Vancouver, British Columbia

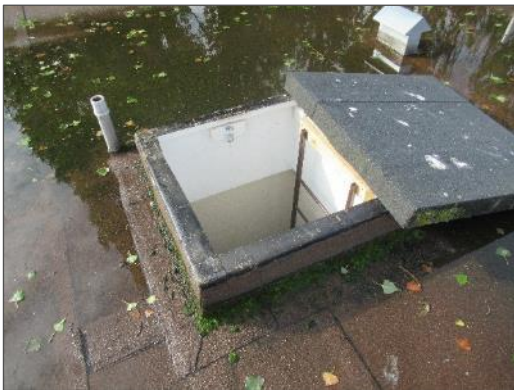
View of the rooftop hatch.

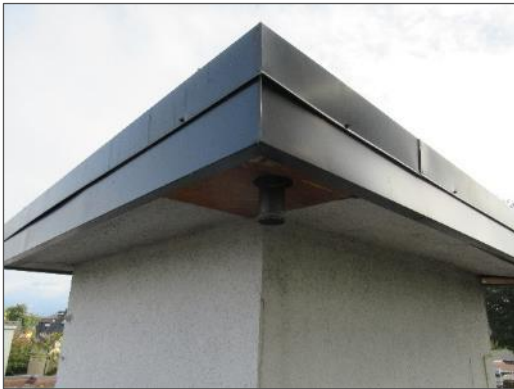
View of missing downspouts.

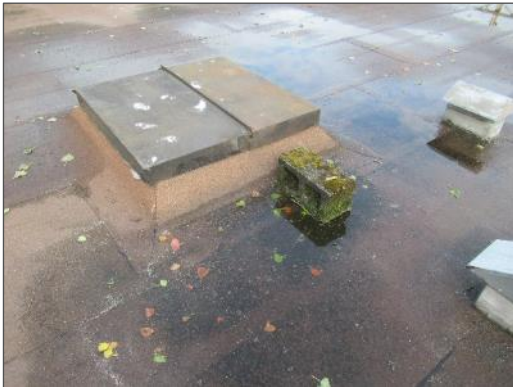
View of debris atop the roof.

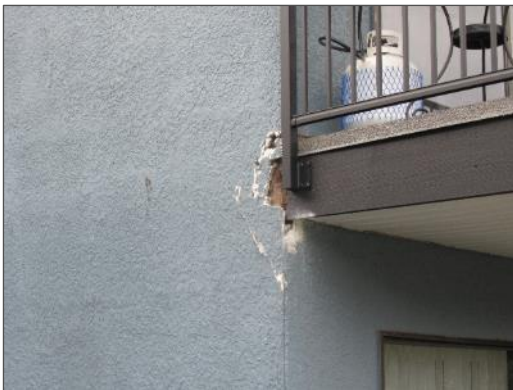
View of damages on the south elevation of the Site Building.

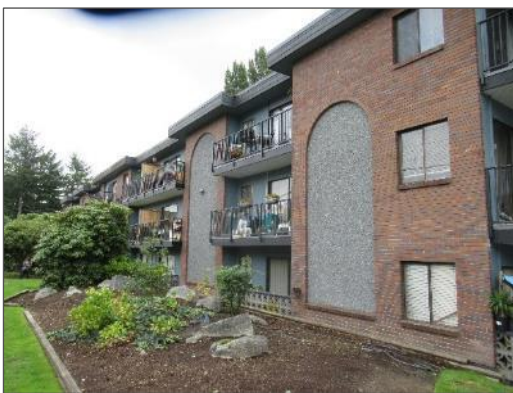
General view of exterior walls and windows.

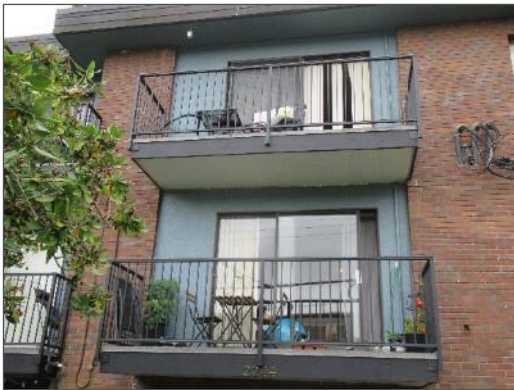
General view of the balconies.

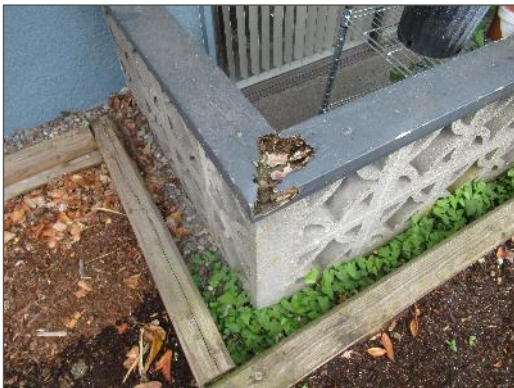
View of damage to the wooden portion of the fall arrest on the ground floor walk out patios.

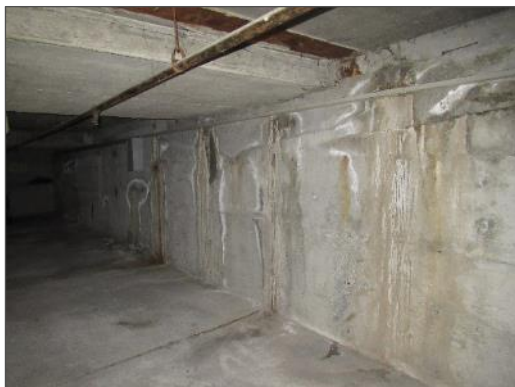
View of efflorescence on the foundation wall within the UPG.

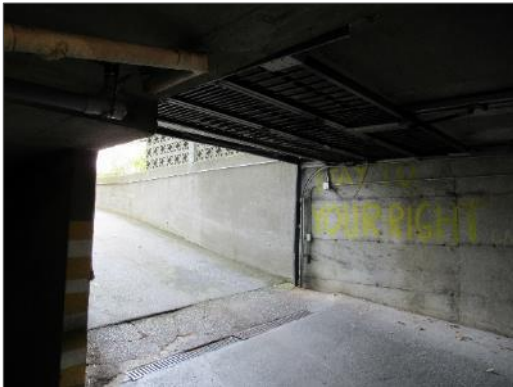
View of the motorized sectional insulated metal doors on the east portion of the site leading to the underground parking garage, Pinchin noted that the motor did not work during the time of the visit.

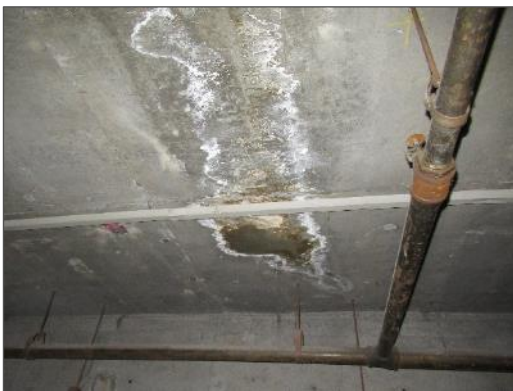
View of efflorescence on the soffit of the UPG.

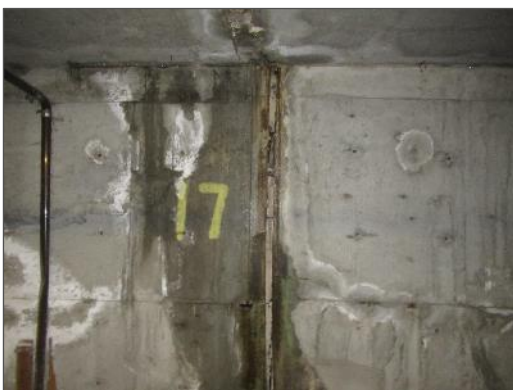
Water ingress on the south portion of the UPG as well as a view of the deteriorated expansion joint in the same location.

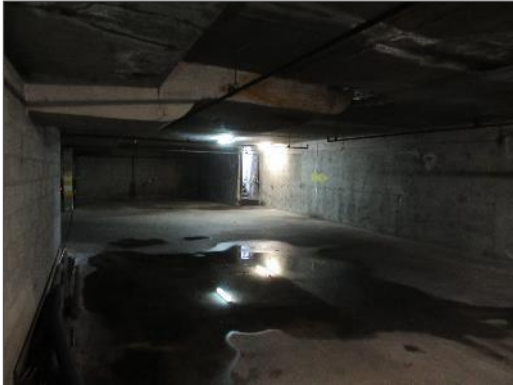
Water ingress on the south portion of the UPG.

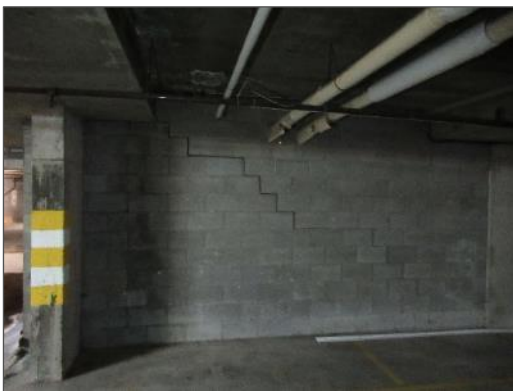
View of step cracking in the concrete block masonry wall with the underground parking garage.

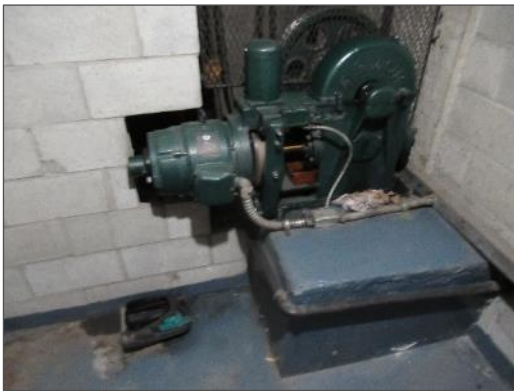
View of the elevator drive.

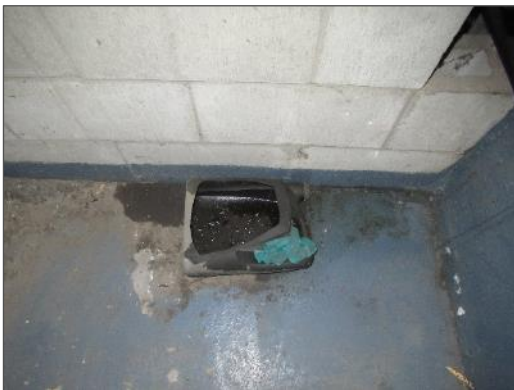
View of the “oil collection system” used in the site as well as minor oil stains on the floor.

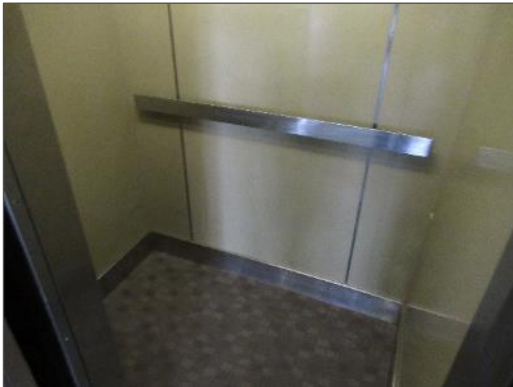
View of the interior of the elevator.

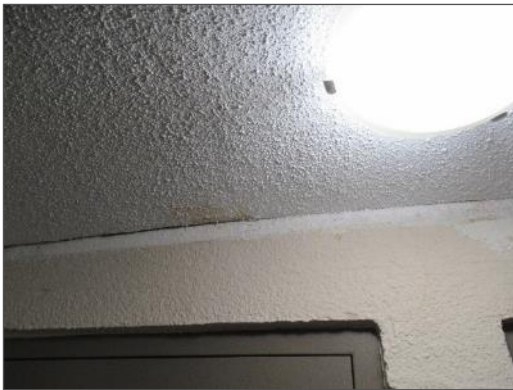
Minor area of staining in the hallways.

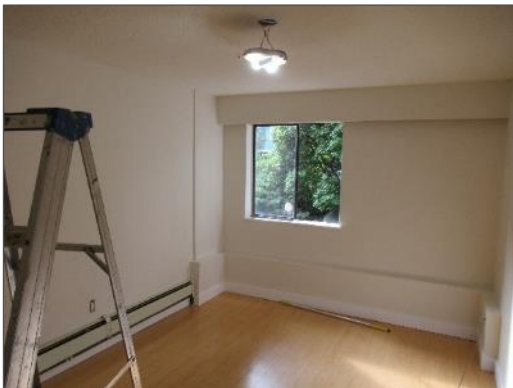
View of typical flooring and interior walls within the tenant spaces.

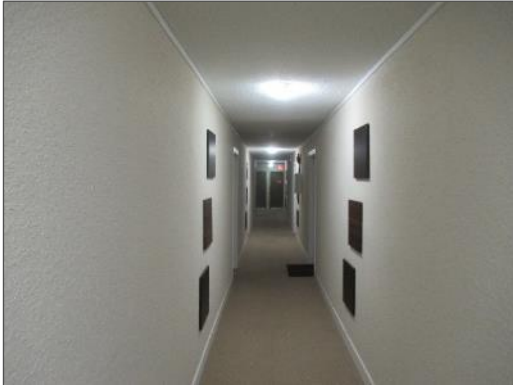
Typical view of common space area within the Site Building.

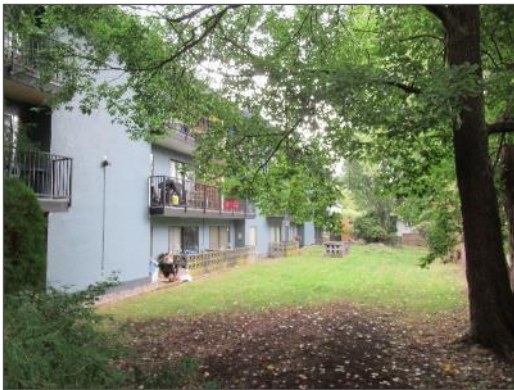
View of the soft landscaping on the south portion of the Site.

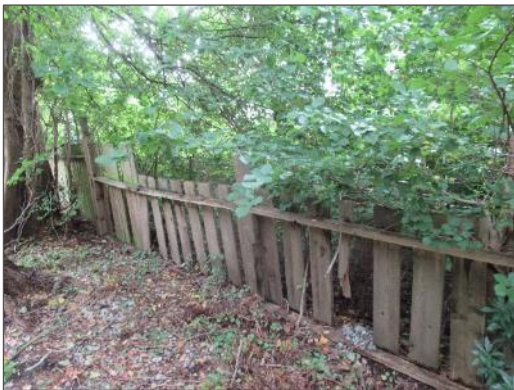
View of the damaged fencing on the south portion of the site.

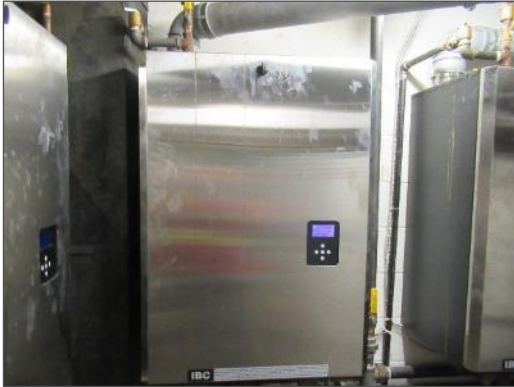
View of the natural gas water boiler.

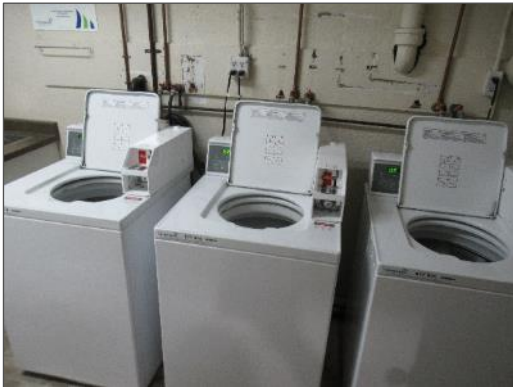
View of the washer machines in the UPG.

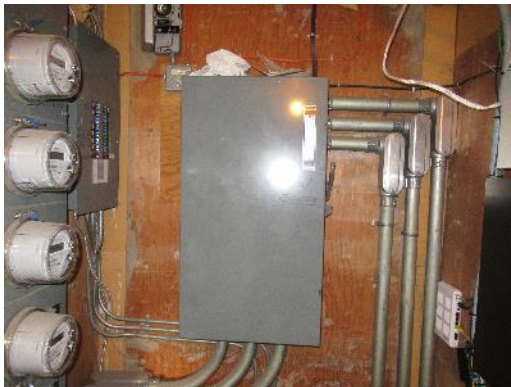
View of the main electrical disconnect switch.

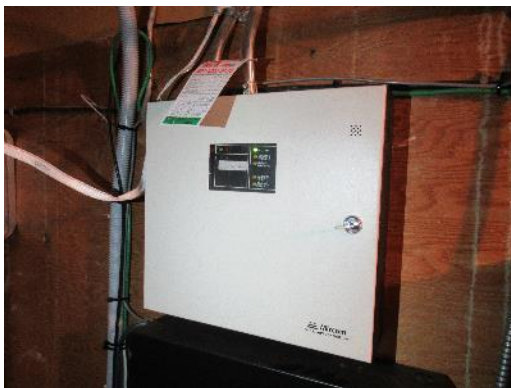
View of the “Mircom” fire alarm panel.
