CHANGE ORDER

Contract Number bcjv0119_03
Change Order Number 01
Date 02/07/2023
Project Garage Membrane
Address 2244 W 6th Ave, Vancouver, British Columbia
Owner Vancouver No. 1 Partnership Managed by InterRent Holdings Manager Limited Partnership
Contractor Flagship Construction and Building Envelope Restoration Ltd.

Project: Structural Engineering Review Job #: JA22058

RE: Structural review of existing structural deficiency and remedy proposed

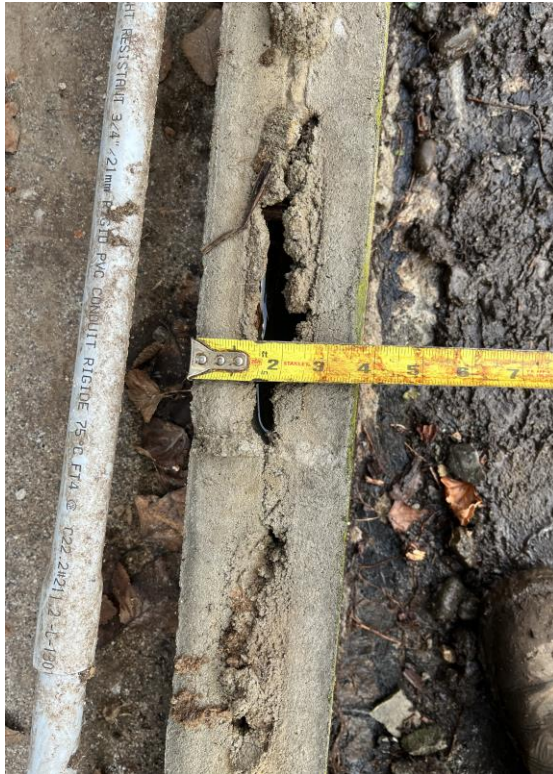
Balcony Concrete Curb 1

In summary, the existing concrete curb is found to be too thin (only 4 inches), hollow cored and contains some loose blocks. For these reasons the existing concrete curb is not structurally sound enough to mount the new railing on. Therefore, it is recommended to that a new concrete curb be poured to anchor the new railing.

Description	Estimate
<p>Balconies (South) Curb Wall: Total of 5 Balconies</p> <ol style="list-style-type: none"> 1. Demo & dispose of all 5 balconies bottom course concrete block curbs. 2. Supply, drill & install new rebar dowel at 16" OC (on center) into the concrete slab with epoxy and add 1 - 15mm horizontal rebar at the top & bottom of the new curb wall. 3. Supply & build concrete formwork for new curb walls – 6 inches thick x 18 inches high. Block out 4 inches opening at the curb for drainage. 4. Supply & place concrete for curb walls 5. Strip & dispose concrete formwork upon pouring & curing of the new concrete curb wall. 	<p>\$11,300.00</p>

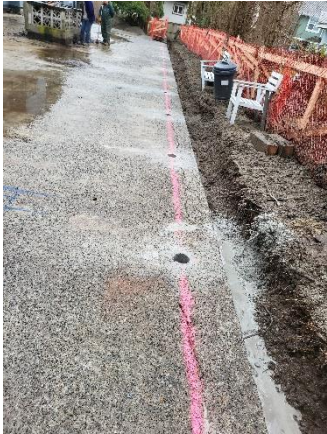
1.1	While on site it was observed, the concrete along the South elevation, deck has cracking, Structural engineer had review the scan result and indicated the original construction did not comply to the industry standard and is unsafe. To decrease the potential risk structure engineer recommend reinforce and support along the crack location. (See structural report)	Contractor/ Owner

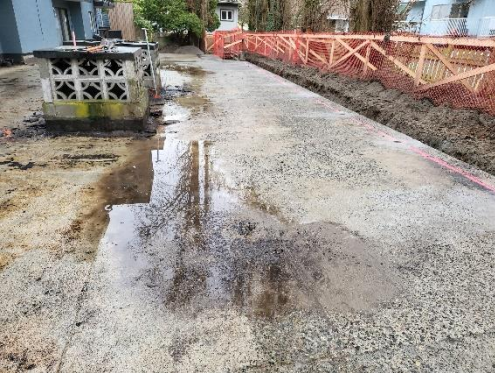
1.2	Significant ponding was observed at middle of the concrete deck. Since the existing drains and pipes are corroded and is not located on at the most lowest point. TCC recommend: 1. Core new drain locations. At the ponding locations. 2. Install new drain and piping to direct water.	Contractor/ Owner

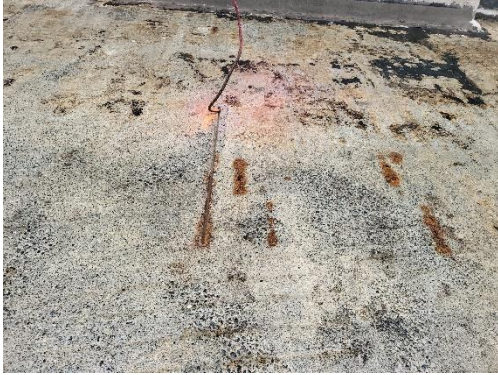
Contractor to get prior approval from owner before starting.			
1.3	Significant corrosion rebar was observed at the concrete deck. Unfortunately, there are nothing that can be done at this point time, unless significant work are carried out. Owner was advised to try to reduce the load on the concrete deck.

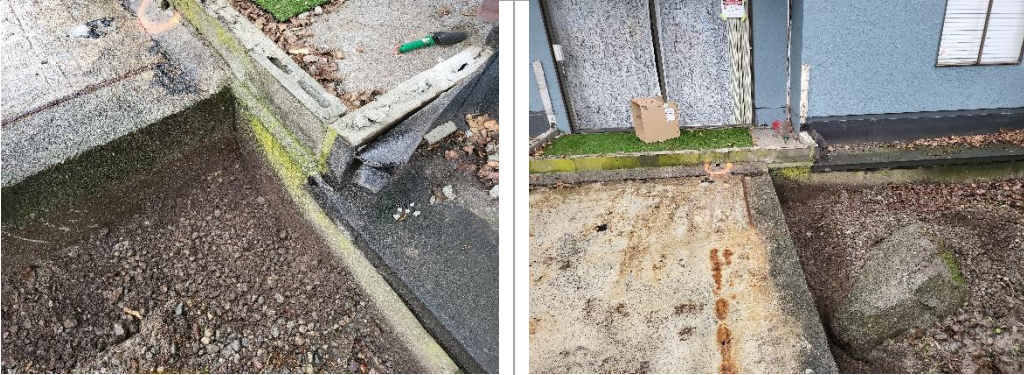
Info	
1.4	The existing concrete curbs at the four balconies appears to be hollow and is not as per design intent originally. those curbs will not be able to West and below for railing attachment. TCC recommends the curbs to be removed and new concrete is to be poured. Contractor to provide pricing and obtain authorization before work starts		Contractor/ Owner

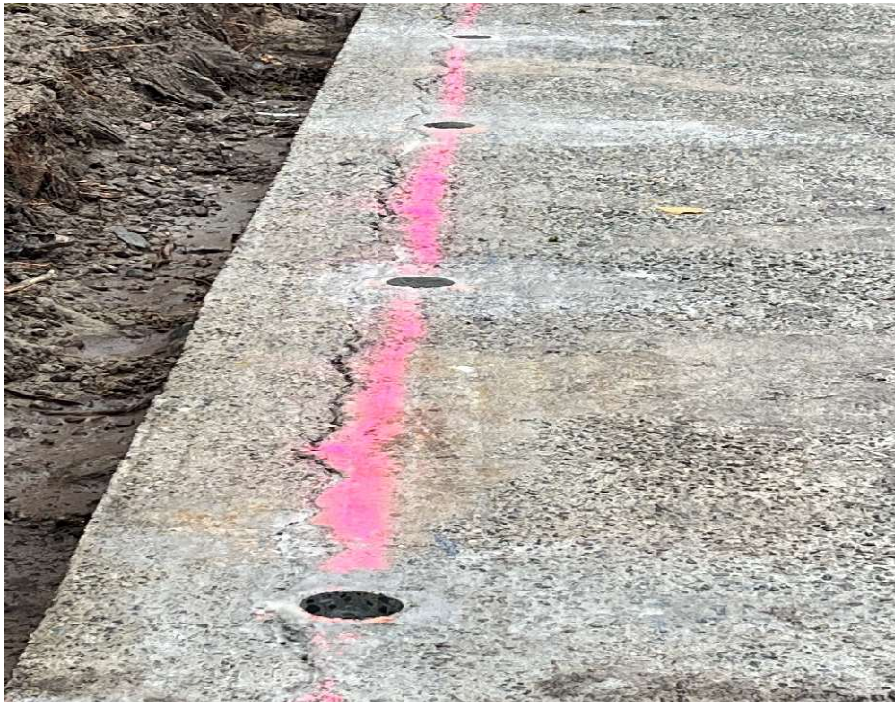
- 1) A continuous cracking was observed along the south basement wall of parking lot, following the removal of topsoil on the concrete slab and power washing, see picture 1 & 1A for detailed info. However, no cracking was found on other supporting sides of slab.

Picture 1: Continuous cracking along basement wall on south

- 1) In addition to the basement wall repair works proposed, the new concrete wall thickening shall be increased to 8" min. to provide adequate bearing support for slab above after its cracking and all the related rebars and dowels shall be increased accordingly. Meanwhile, the new thickening part of wall shall be carried down to foundation as well for the extra gravity load from slab. The existing slab on grade shall be cut to suit this and repaired after. The existing foundation might be expanded and reinforced after excavation, if required.

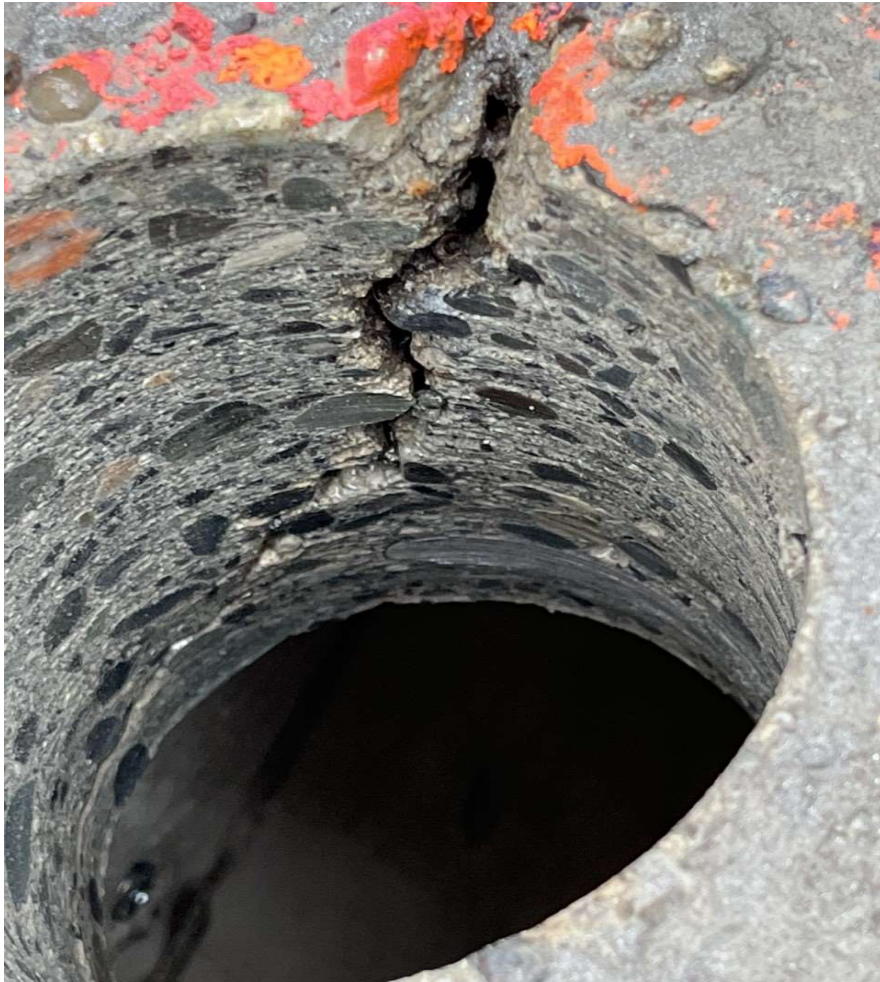
Picture 1A: Cracking observed from core hole

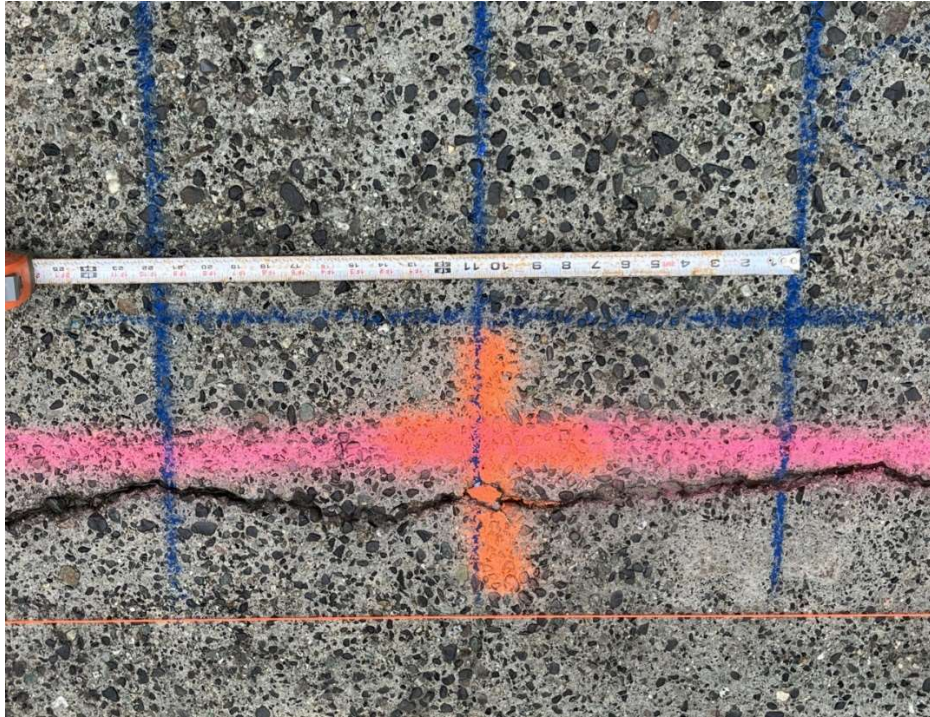
- 2) It was also observed on site that there was no cold joint between the concrete slab and basement. The slab and wall were placed monolithic without providing any top reinforcing at slab edge which doesn't meet the concrete construction standard at all. (See picture 2 for reference) The blue rebars scanned are all bottom ones. Therefore, the negative bending at the edge of slab along the basement wall caused a significant tension at top of slab and directly resulted in the cracking of slab from the top. This cracking has been developed and almost extended to the bottom rebars at some locations as a long-term effect. (See picture 1A). It can also be concluded by observing the cored cylinder from concrete slab on site. (See picture 3 & 4)

Picture 2: only bottom reinforcing found from X-Ray

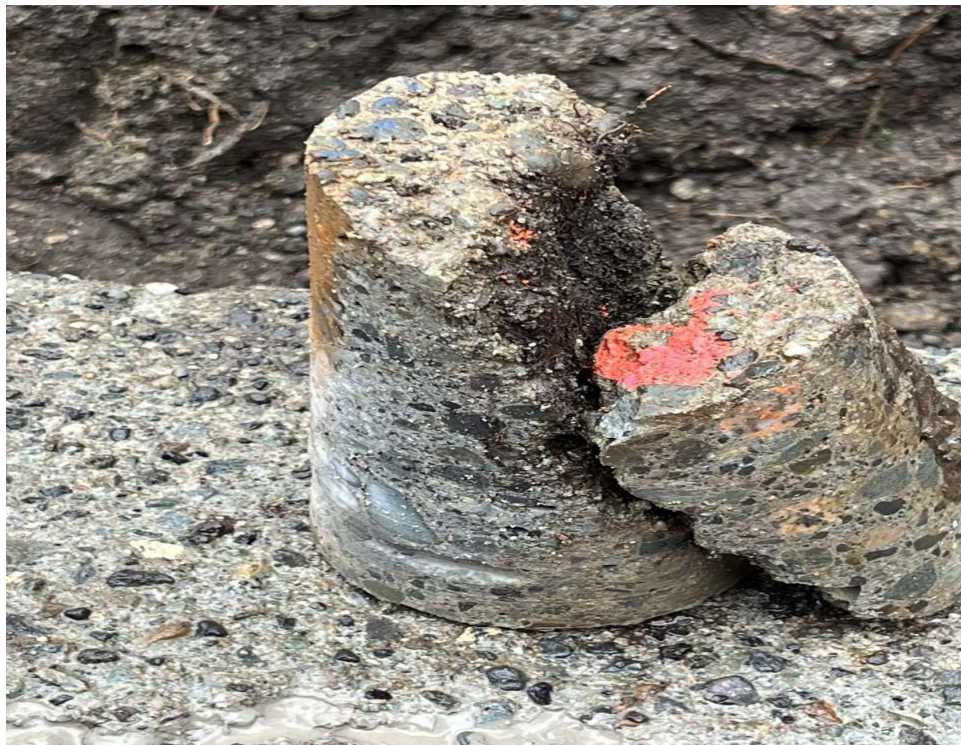
Picture 3: Cored cylinder from concrete slab

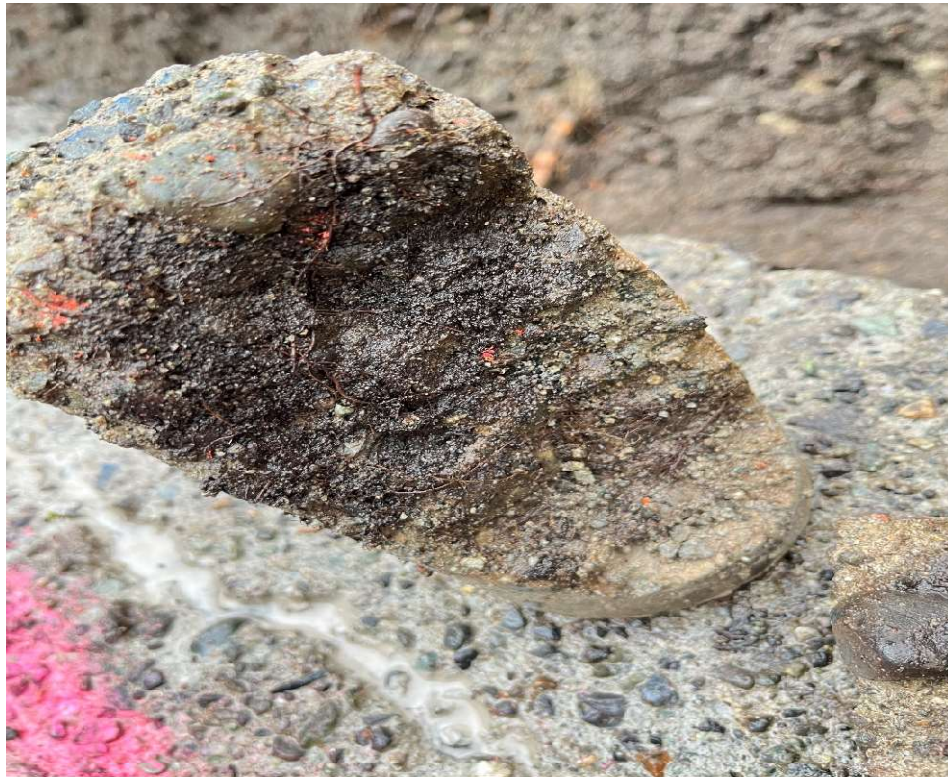
Picture 4: Cored cylinder from concrete slab

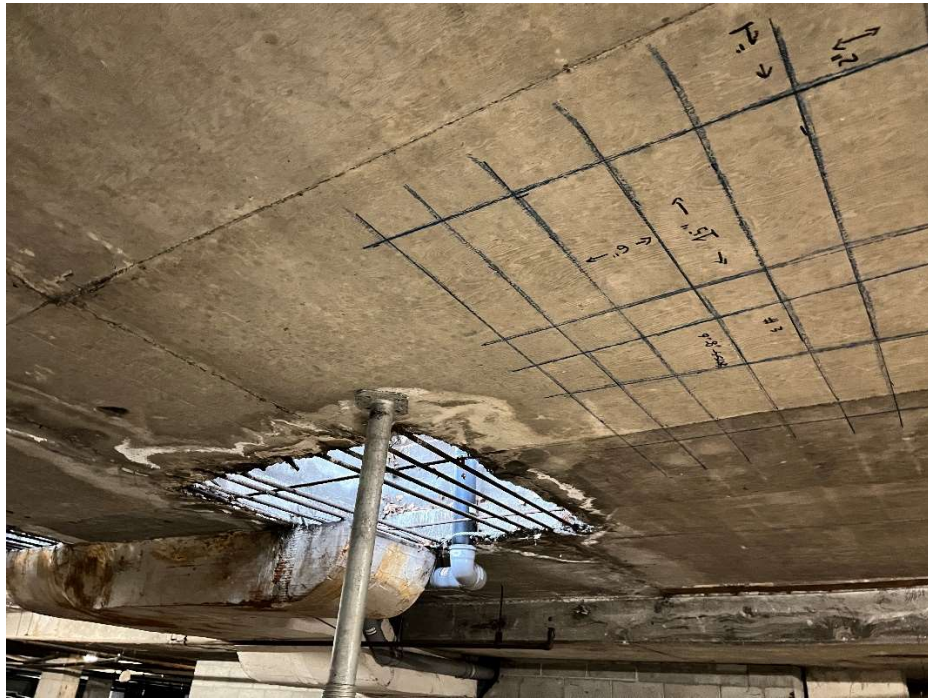
- 3) Based on the slab X-ray results and site measurements, the existing slab is around 6 ½" thick and clear span of it is more than 20 feet. The slab span-thickness ratio is far over the code stipulated limit. To be an appropriate design for this concrete slab, either slab thickness or slab reinforcement must be increased significantly to meet the current code and load specifications. However, the existing slab reinforcing is only 15M@6"O/C at mid span and the worse situation is that the concrete cover for both top and bottom reinforcing is not adequate at all and some bottom and top rebars already exposed and got seriously rusted. This will seriously affect the slab performance in the future. (See picture 5, 6 & 7 below for information)

Picture 5: Scanned rebar and exposed rebar

- 2) As the existing slab was under designed significantly and some rebars were even not placed properly with adequate concrete cover, the future use of related slab area must be restricted to certain degree to avoid overloading to the current slab. Related landscape design must be carried out appropriately to help reduce the load on this slab area as far as possible.

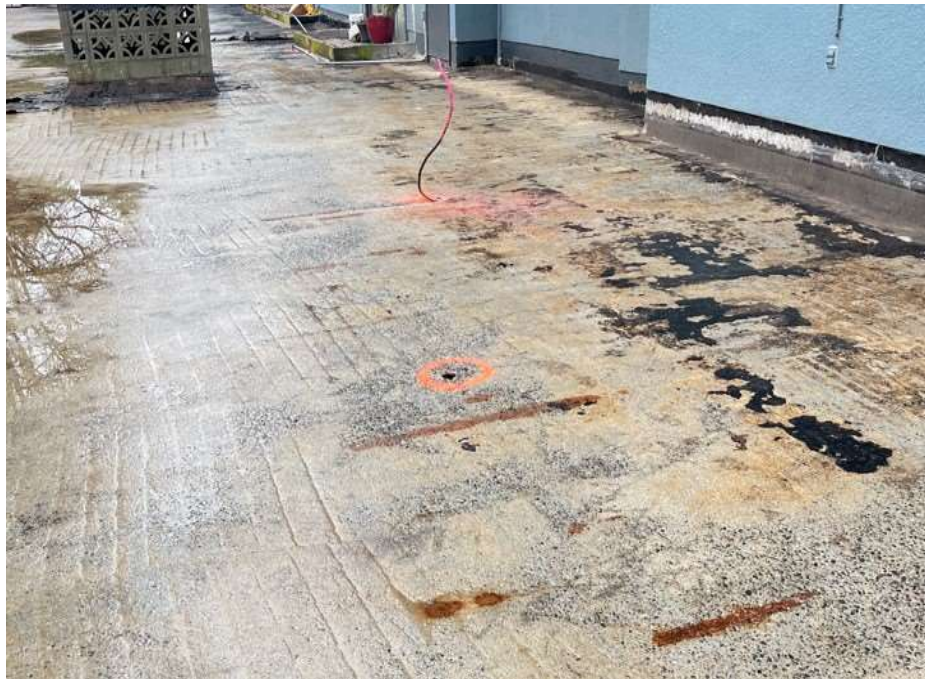
Picture 6: Exposed top rebar

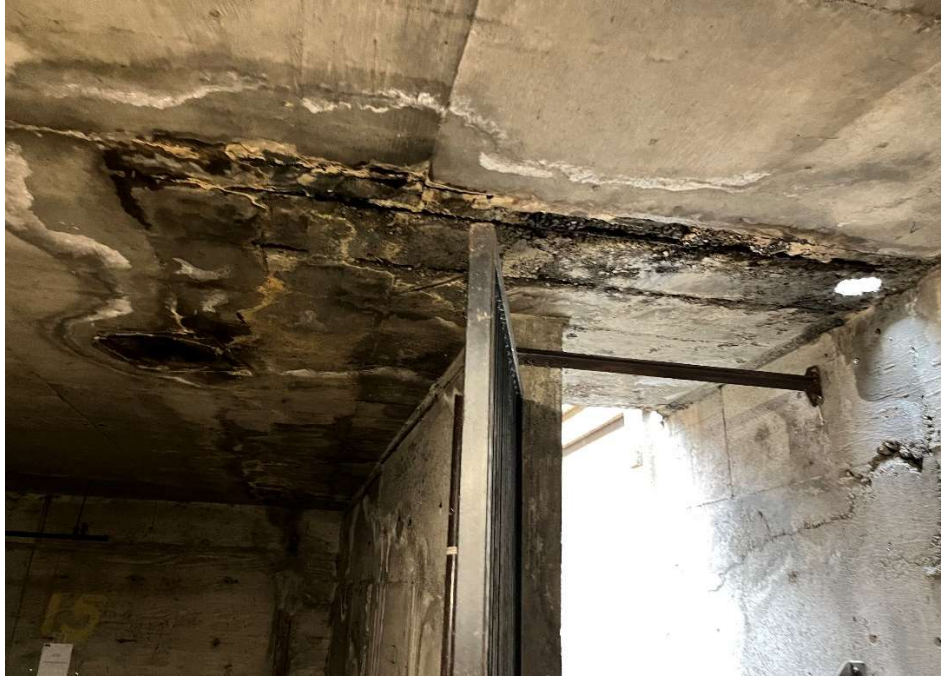
Picture 7: Exposed bottom rebars
