Client:	CAPREIT GP Inc.	Report Date:	23-Mar-2021
Attention:	John Fitzgerald Anuradha Bandara Maria Trotea	Email:	JohnF@CCMSProjects.com A.Bandara@capreit.net m.trotea@capreit.net
Contractor:	The Restorers Group Inc.	Email:	pat@restorersgroup.ca
Project:	12184,12186,12188 & 12190 224 Street Maple Ridge, BC- Balcony Repairs.	Site Visit:	23-Mar-2021
		Weather:	11°C

OBSERVATIONS AND COMMENTS:

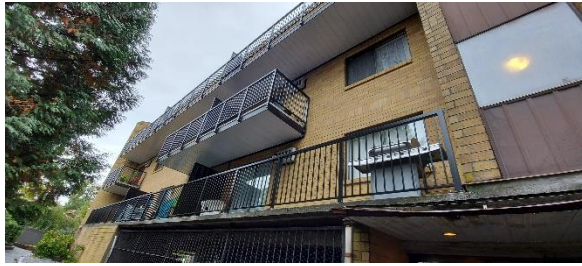
No.	Description	Photo
10.1	Installation of new vinyl membrane, aluminium railing & aluminium privacy screen were completed on south elevation of building D.

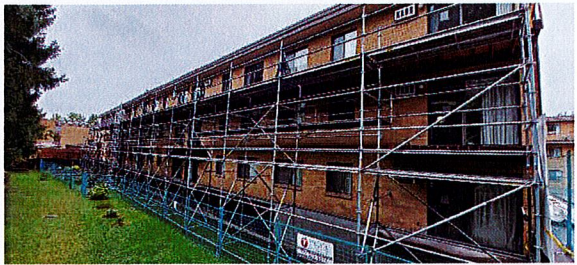
No.	Description	Photo
11.1	Installation of scaffolding on south elevation of building C was completed. Removal of existing guardrails, vinyl membrane & vinyl soffit was complete.
